CRYSTAL RIVER, SEGMENT 2

Base of McClure Pass to the Roaring Fork River

6.13.1 Crystal River, Segment 2

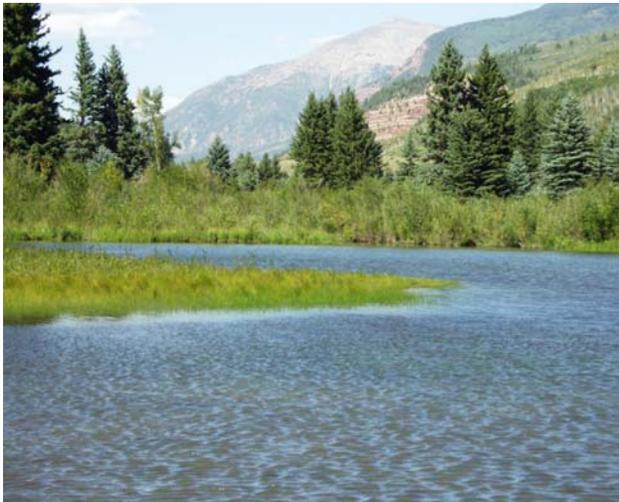
Beaver have built dams that create open water ponds where waterfowl, shorebirds and others find refuge.

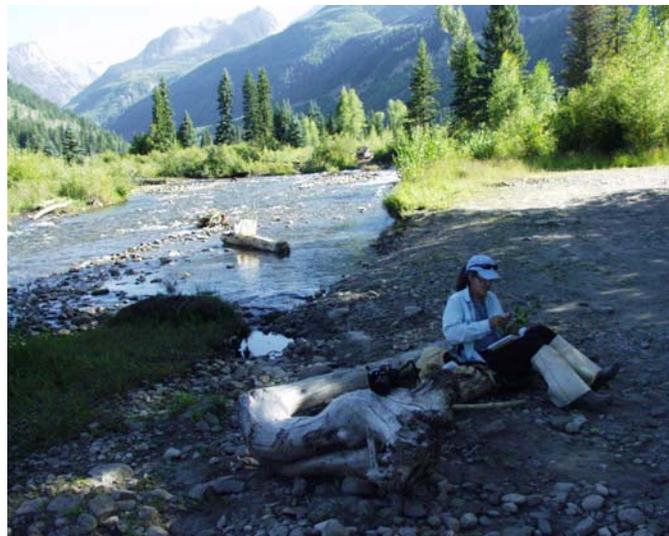
Janis Huggins (project botanist) is writing up her field notes while sitting on a stream bank that has been severely degraded by trampling.

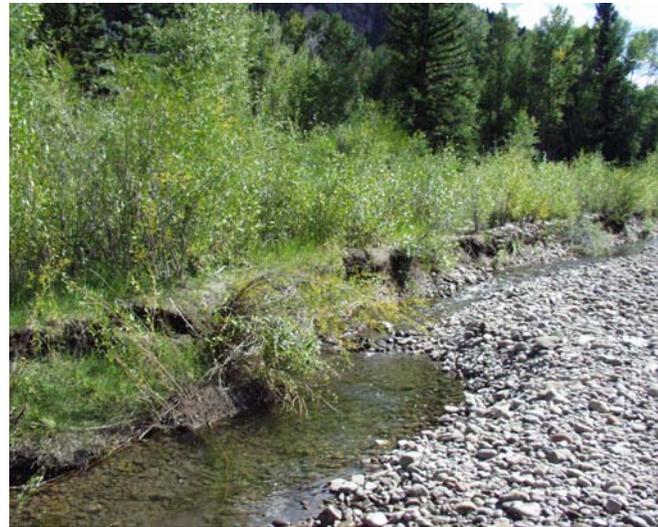
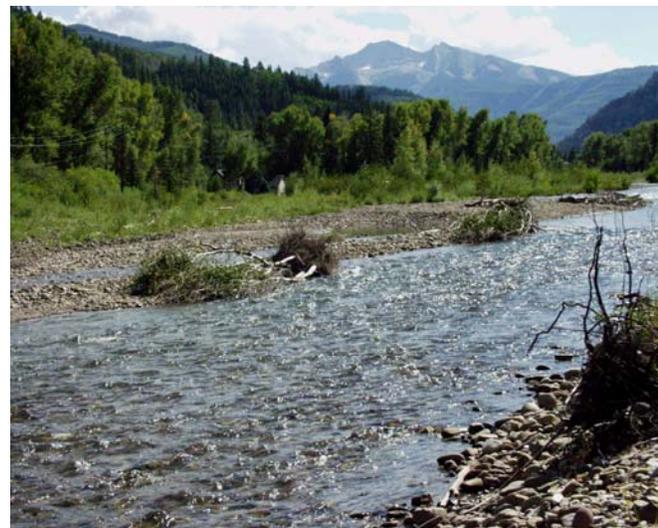
Above: Excessive bank erosion has resulted from increased stream energy and excessive sediment loads.

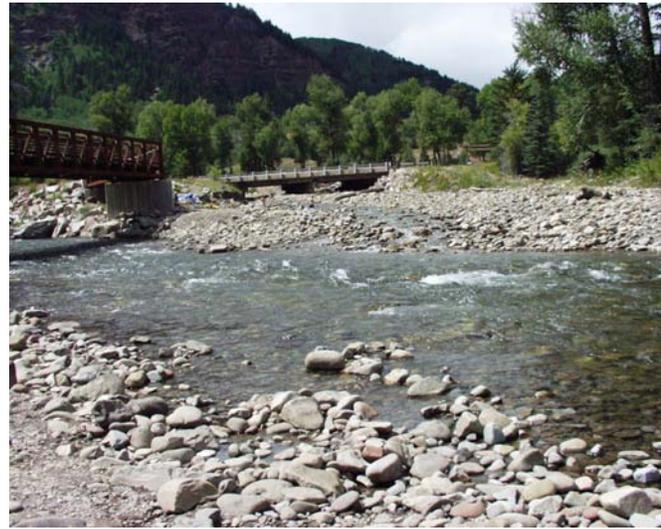
At the confluence of Coal Creek and the Crystal River, bank erosion and frequent movement of stream substrate degrades wildlife habitat.

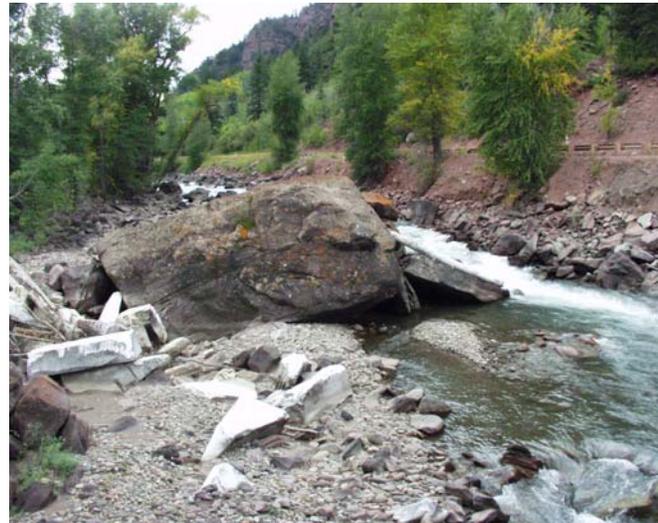
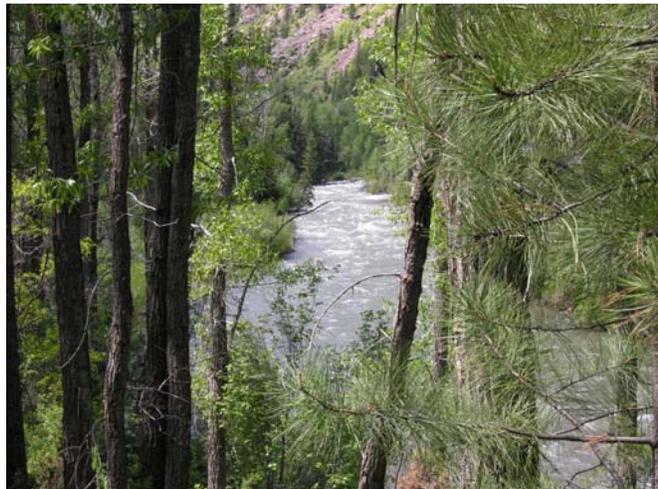
Above: At the top of the reach the stream is channelized by Highway 133 on the left bank (photo right) and by a railroad grade on the right bank.

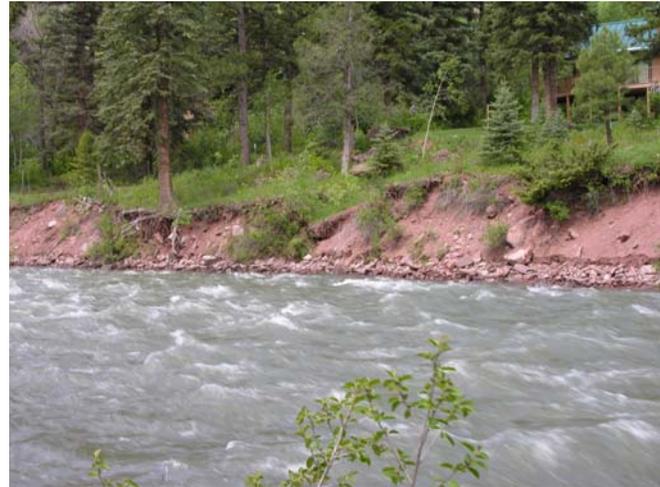
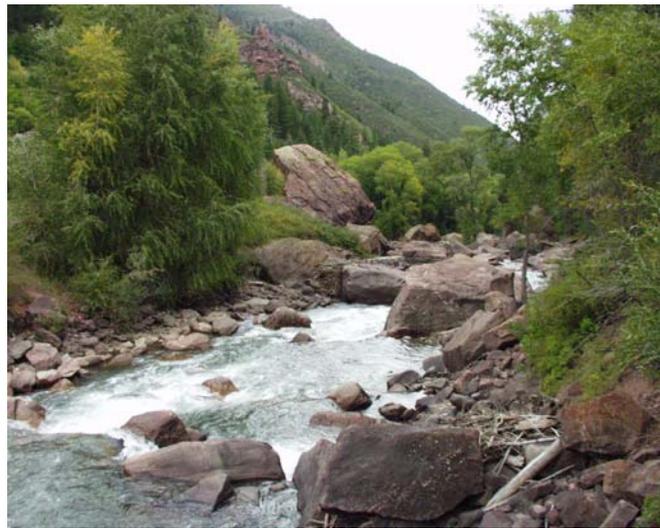
Above: Housing development with commensurate removal of riparian vegetation has resulted in bank erosion.

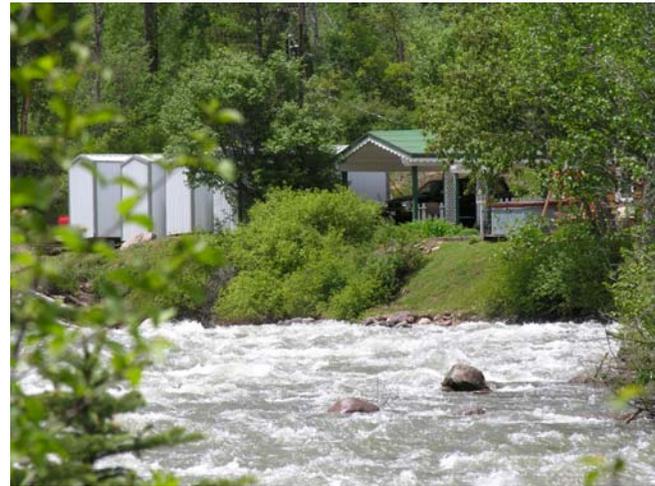
Home development on stream banks has decreased bank stability.

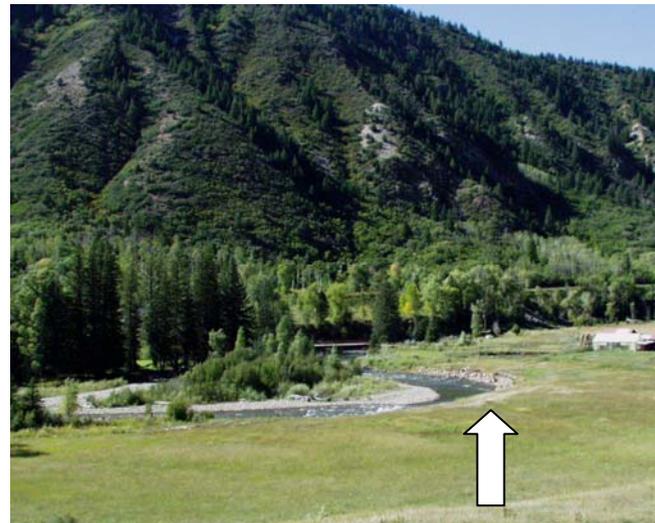
At the top of the reach, large meanders still occur, increasing stream habitat variety. However, historic agricultural development that destroyed riparian vegetation continues to impact the stream system.

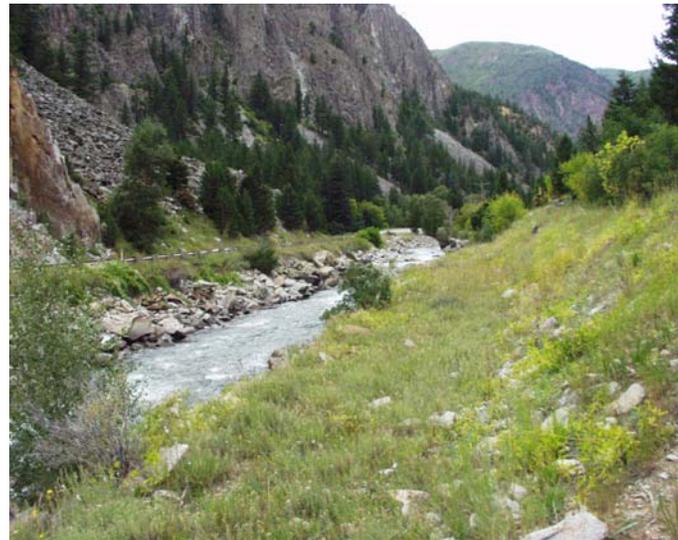
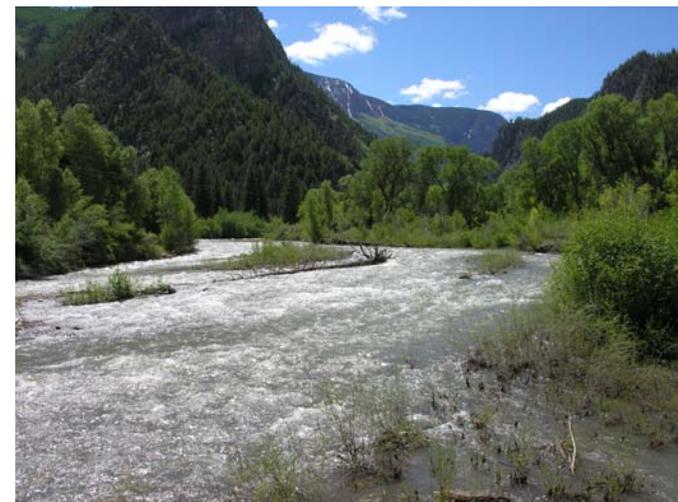
Above: At the top of the reach the highway on the left bank and railroad grade on the right bank severely channelize the stream.

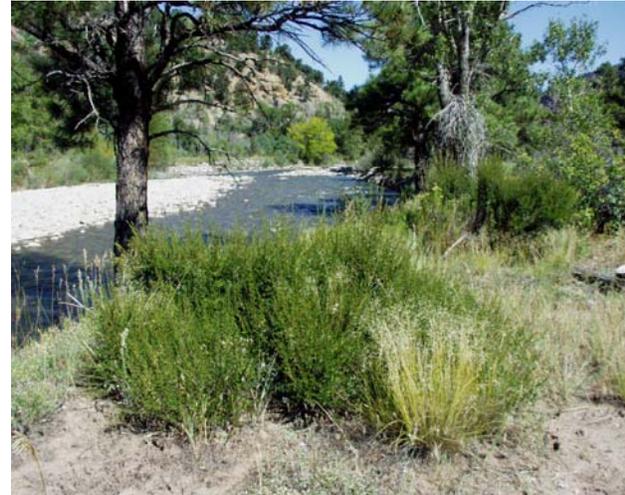
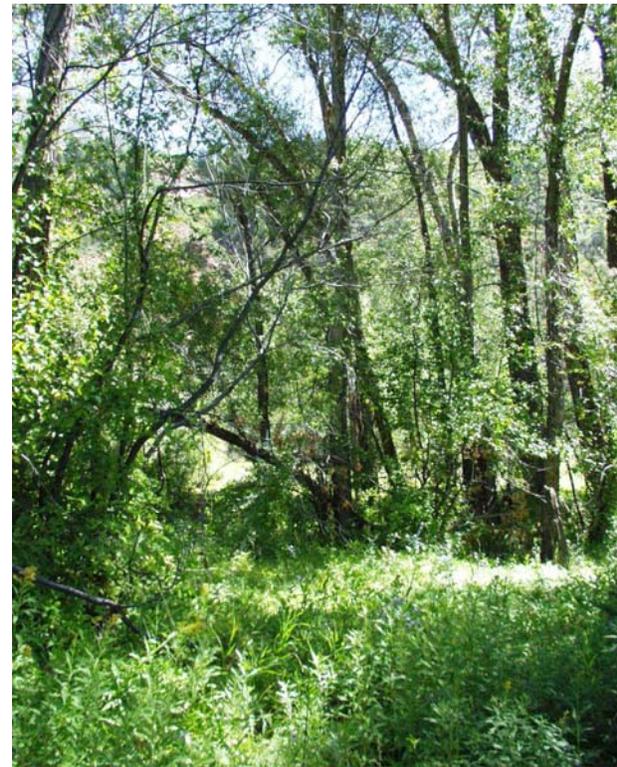
Above: At the Janeway townsite the floodplain has dried out and supports drought-tolerant plant species.

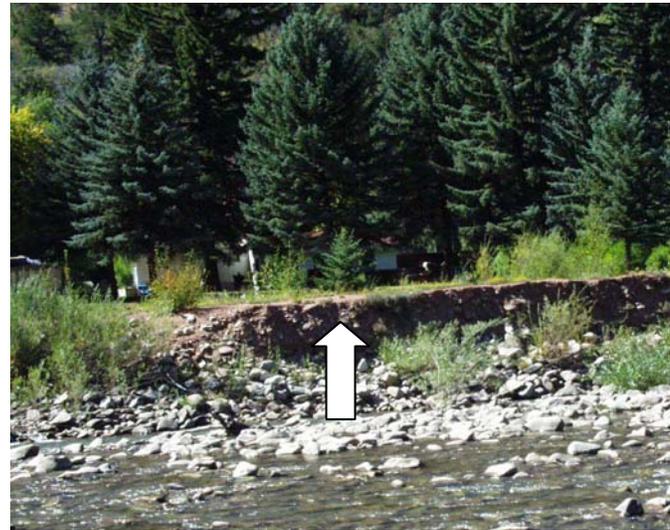
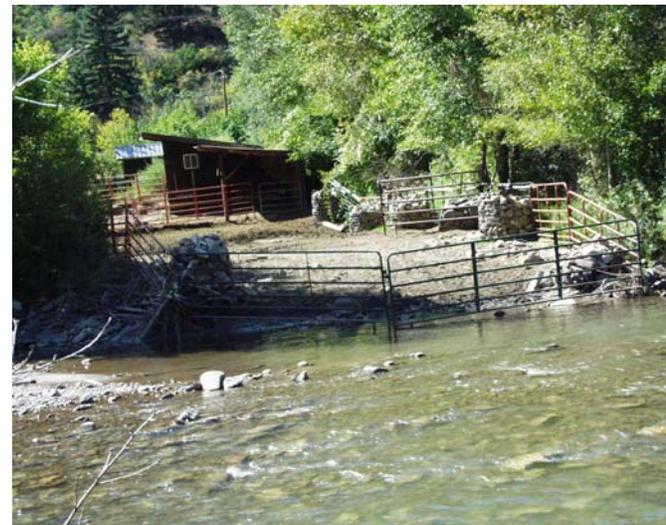
**Above: Downcutting and erosion occur where riparian vegetation has been removed.
Below: Corrals on the stream bank are a source of nutrient and sediment pollution.**

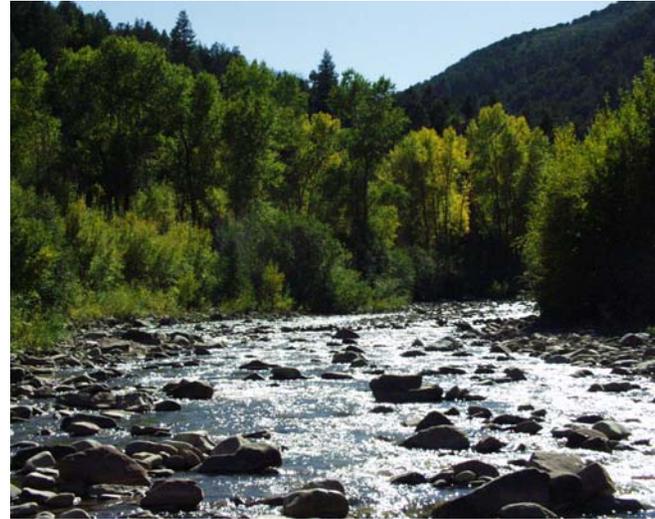
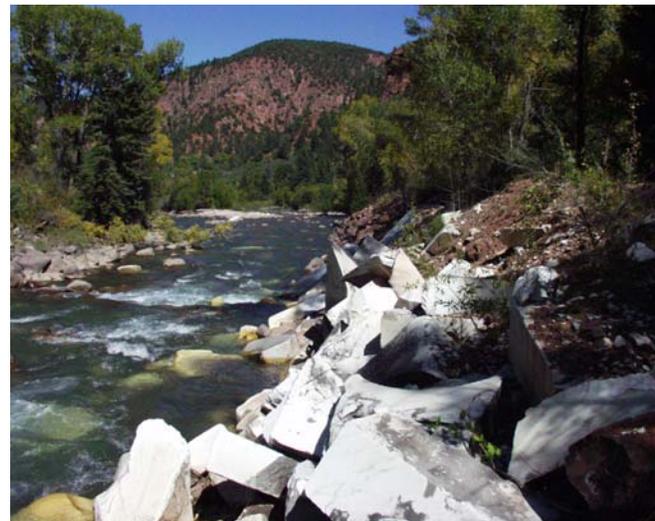
Above: Along natural sections of the reach, riparian vegetation is species rich and structurally complex. Below: Marble riprap destroys stream bank habitat and increases stream energy in the downstream direction.

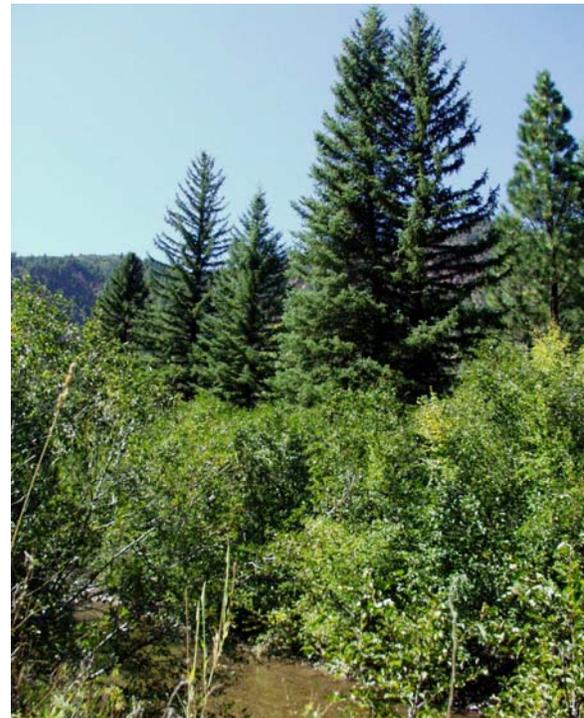
Above: Small pockets of good quality riparian habitat provide some wildlife potential.
Below: Highway 133 degrades stream and riparian habitat and is a lethal barrier to wildlife attempting to access the stream.

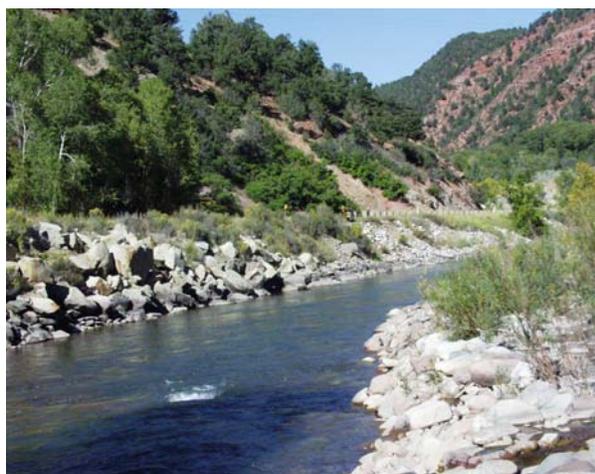
Left: Channelizing impacts of the highway include simplification of stream habitat. Run habitat dominates the velocity/depth regime.

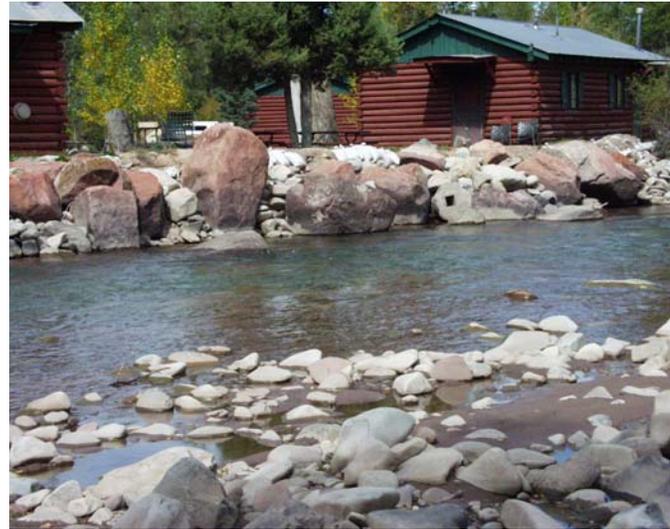
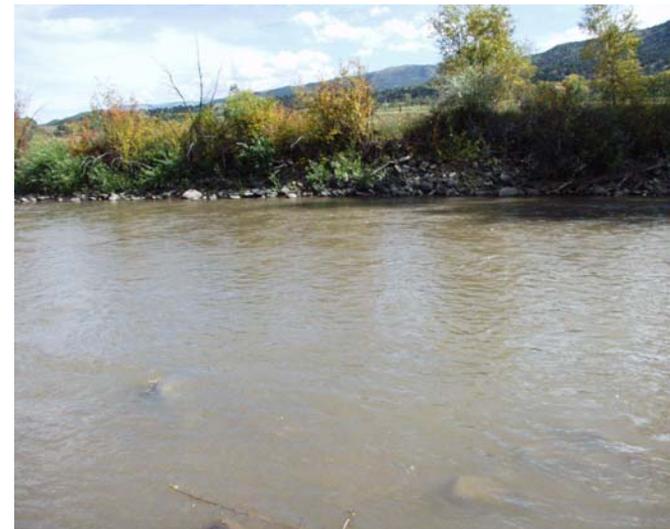
Top: A commercial campground has built into the riparian zone and onto the left bank necessitating riprapped stream banks to prevent flooding but channelizing the stream in the process.

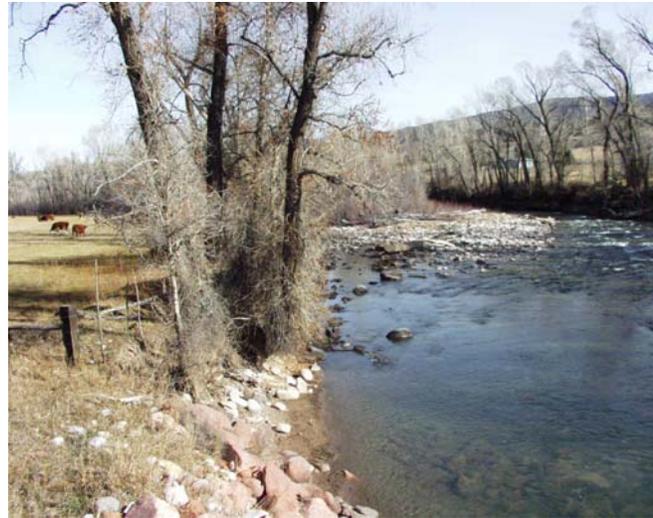
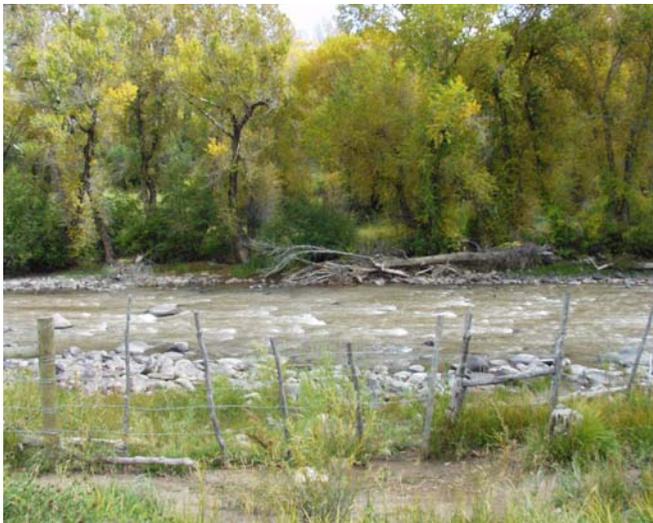
Above: In grazed pastures only a narrow riparian zone remains of a once likely hundreds meter wide riparian zone.

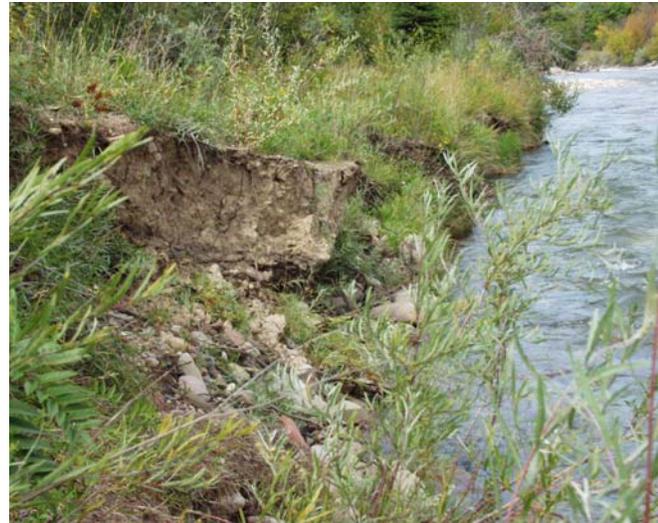
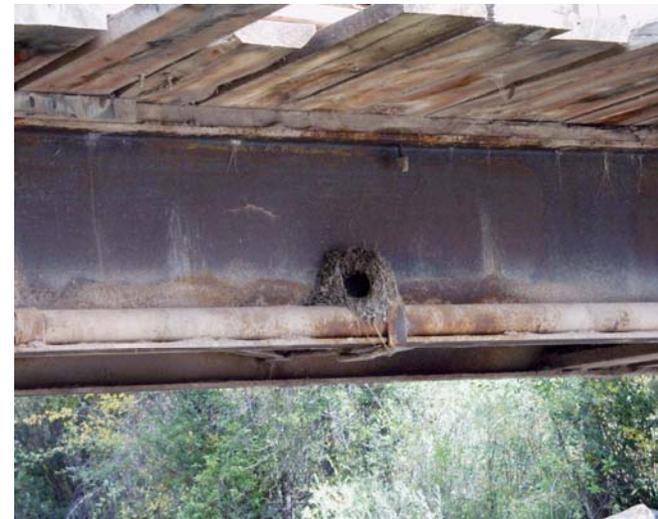
Top: Banks are sloughing where weeds dominate bank vegetation.

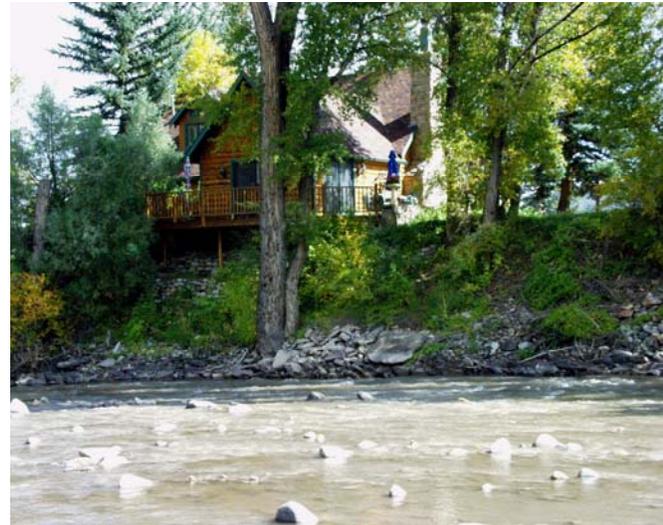
Bank vegetation is degraded and stream banks are destabilized by housing that is located too close to the stream.

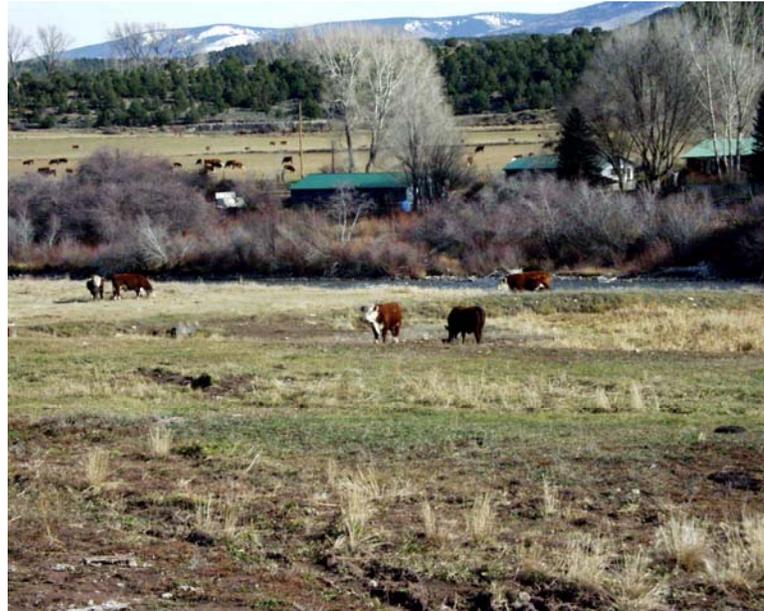
Overgrazing in the riparian zone and grazing on stream banks has eliminated most riparian habitat functions and severely compromised stream water quality.

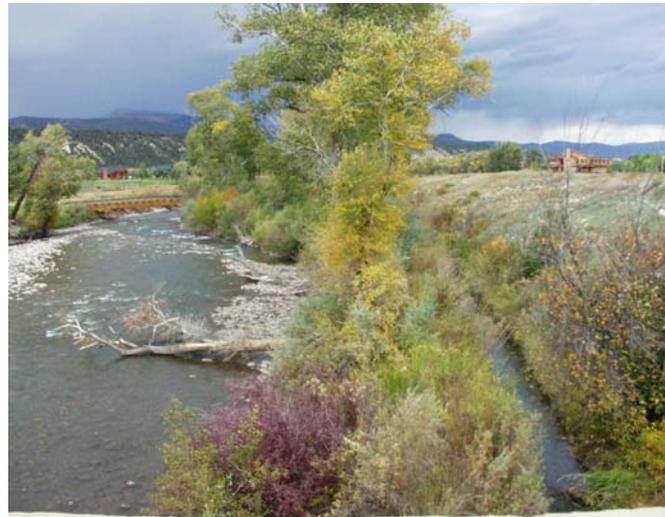
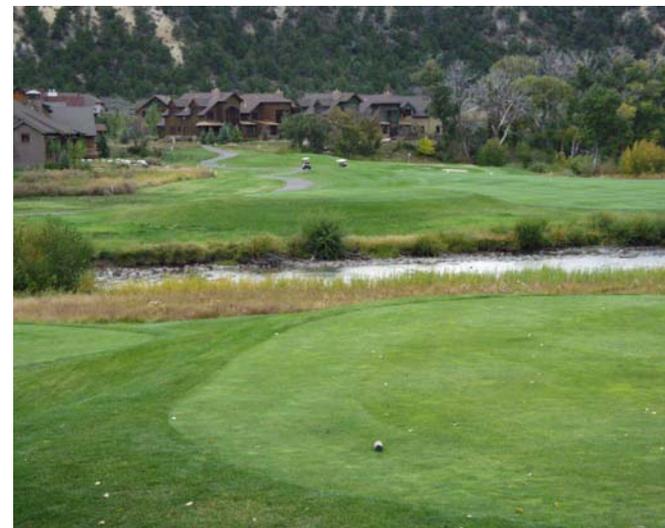
Above: Only a narrow, dysfunctional remnant of a once wide cottonwood forest remains.

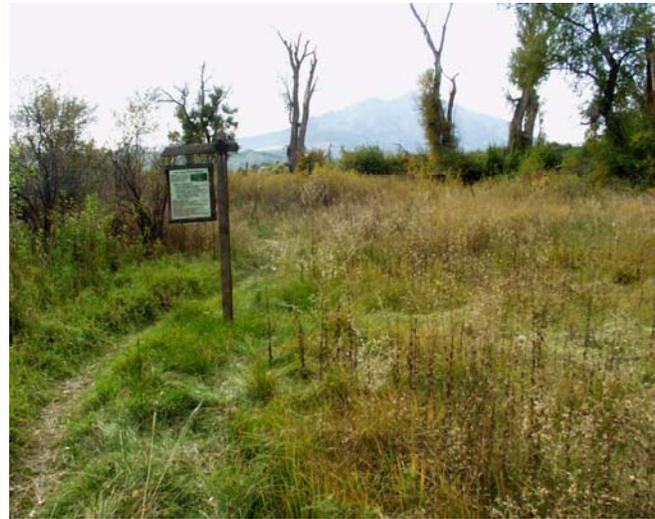
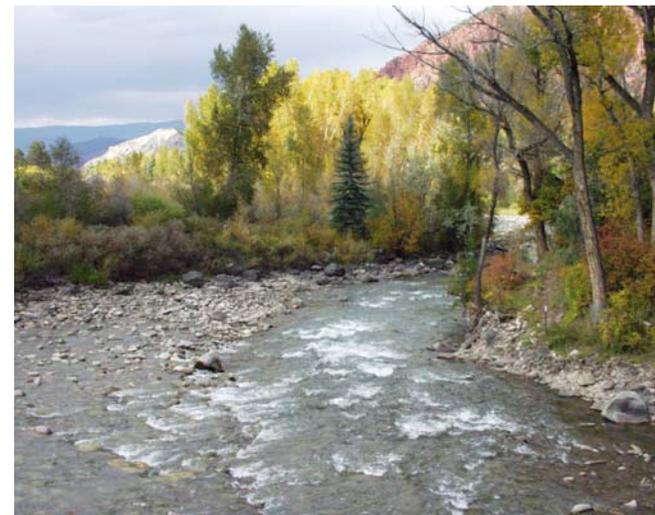
Above: At a designated natural area adjacent to the golf course weeds inundate the riparian zone and degrade habitat potential.

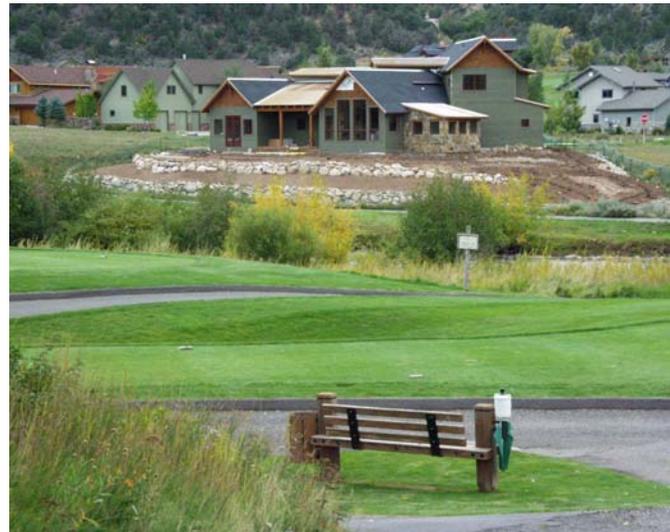
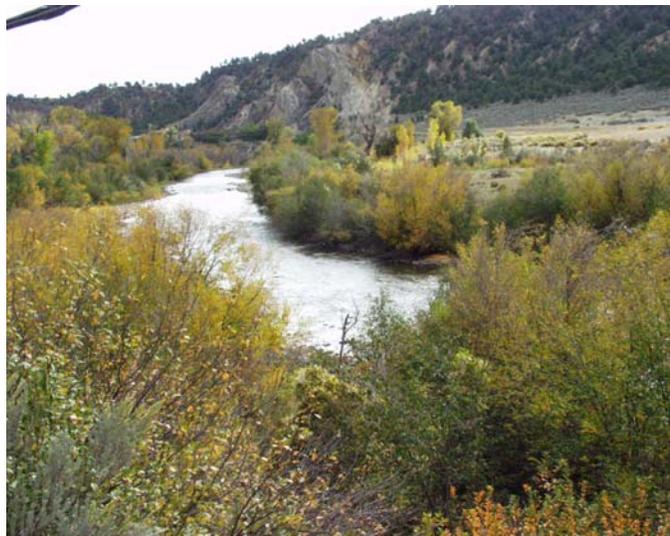
Above: Removal of riparian vegetation has also removed wildlife resources and an essential part of the stream ecosystem thereby eliminating the potential for functional habitat.
