A Review of Aquatic Life and Stream Health in the Roaring Fork Watershed

Timberline Aquatics, Inc.

July 19, 2012

ROARING FORK WATERSHED PLAN

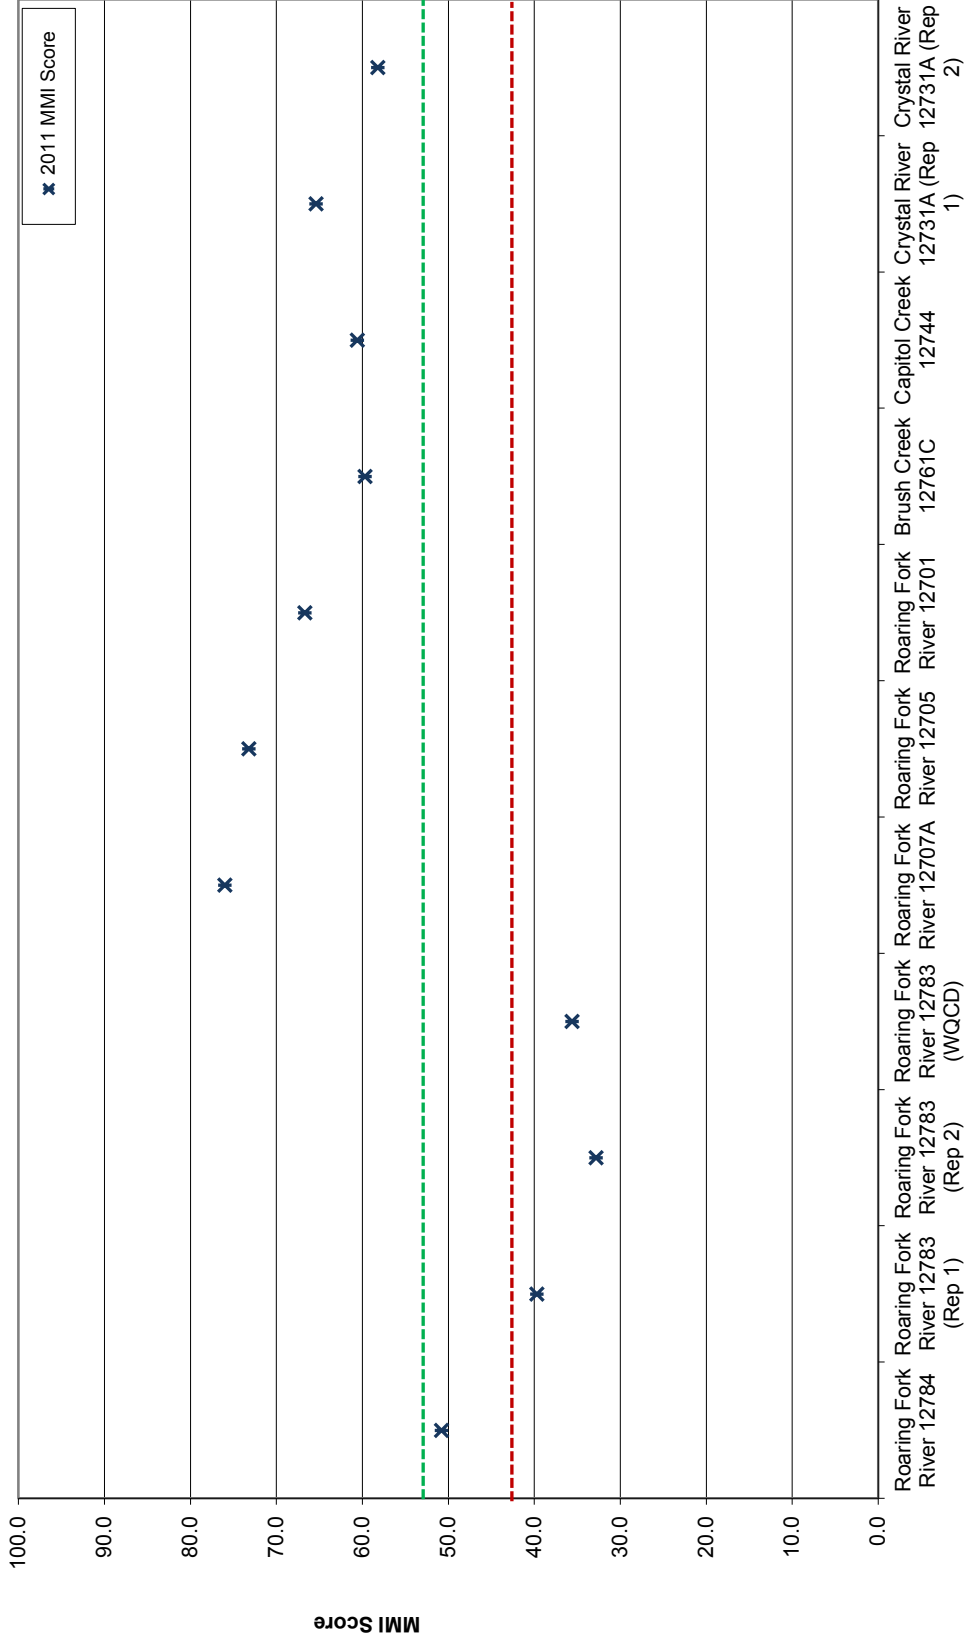
Biotype 1: MMI Scores (Fall 2011)

Figure 2: MMI scores for sites in Biotype 1 (additional sites from Biotype 1 are included in Figure 3). The threshold for aquatic life use attainment is represented by the green dashed line, and the threshold for impairment is represented by the red dashed line.

A wide range of MMI scores were produced from sample sites in the study area, and some of the highest values were achieved at sites located on tributaries to the larger rivers in the watershed (Tables 1 and 2, Figures 2 to 4). Most sites had healthy conditions for aquatic life. Seventeen of the sample sites produced MMI scores surpassing the threshold for attainment of aquatic life use. This suggested that suitable aquatic conditions and relatively healthy benthic macroinvertebrate communities were present at most sites. Of the three sites that did not meet the initial CDPHE requirements for aquatic life use, two sites (Cattle Creek site 12719 and Roaring Fork site 12783) produced scores below the threshold for impairment. One site (Roaring Fork site 12784) produced an MMI score that fell within the “gray zone,” between attainment and impairment (Figures 2 and 3). Auxiliary metric (HBI and Diversity) values indicated that this site was in attainment for aquatic life use.

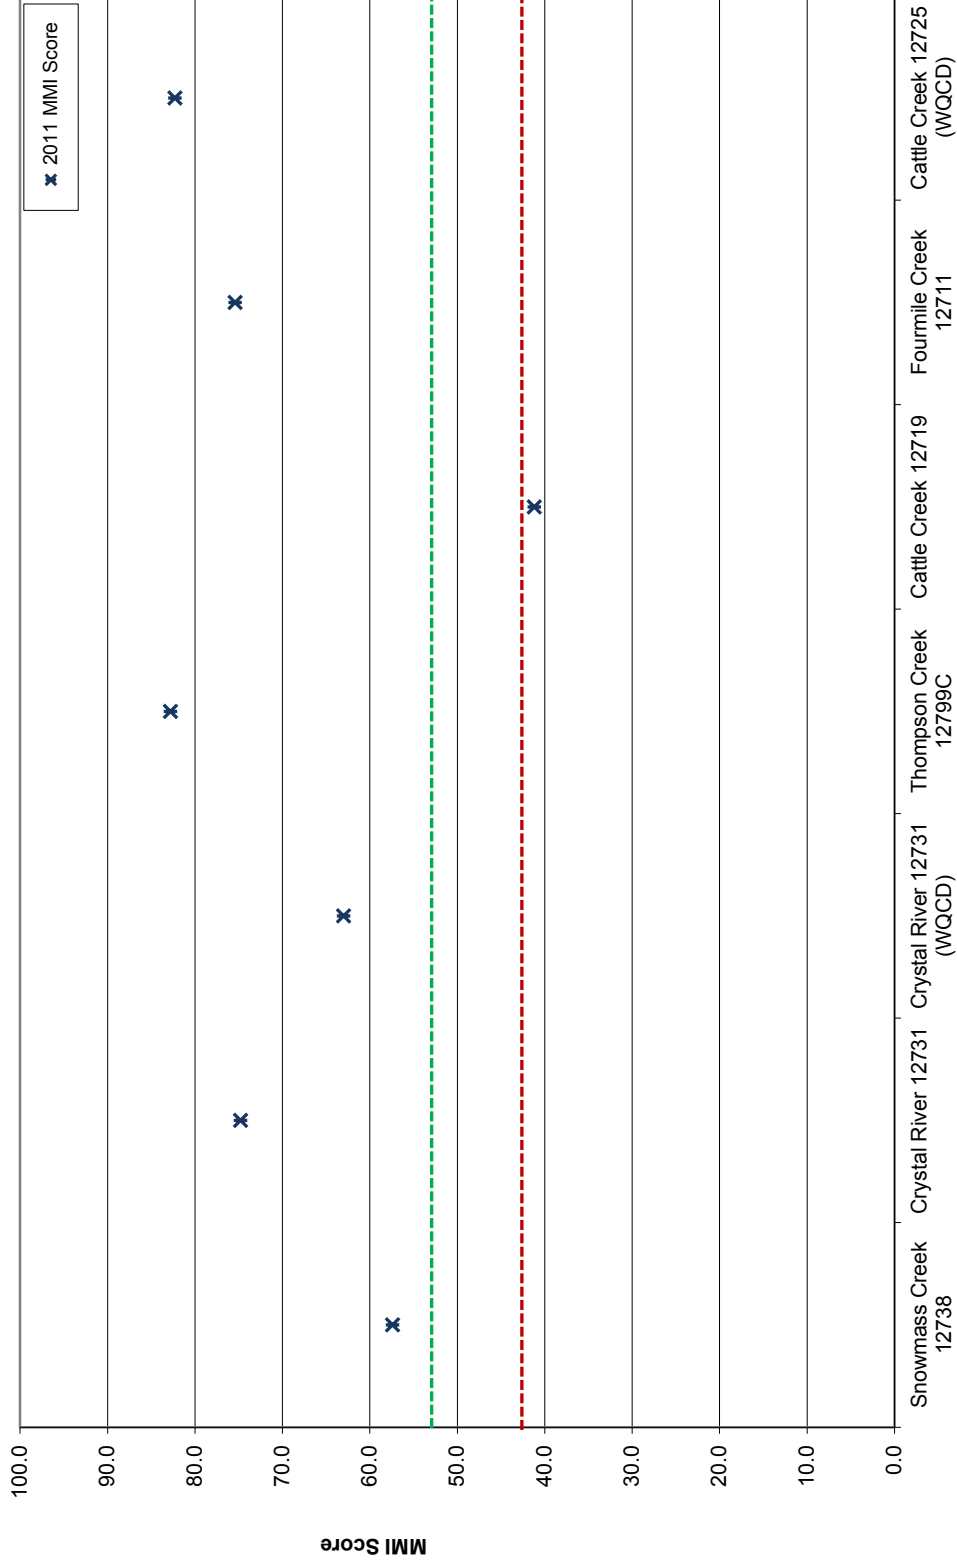
Biotype 1: MMI Scores (Fall 2011)

Figure 3: MMI scores for sites in Biotype 1 (additional sites from Biotype 1 are included in Figure 2). The threshold for aquatic life use attainment is represented by the green dashed line, and the threshold for impairment is represented by the red dashed line.

The highest MMI score for sites located in Biotype 1 (82.8) was obtained from data collected in Thompson Creek, a tributary of Crystal River (Table 1, Figure 3). In Biotype 2, the highest MMI score (86.0) was found at the Crystal River (site 12731B), indicating that this site contained some of the best aquatic conditions for benthic macroinvertebrates in the study area (Table 2, Figure 4). In general, MMI scores and additional data analysis tools suggested that the majority of aquatic habitat in the study area provided adequate conditions for aquatic life. The results for each site are discussed in more detail.

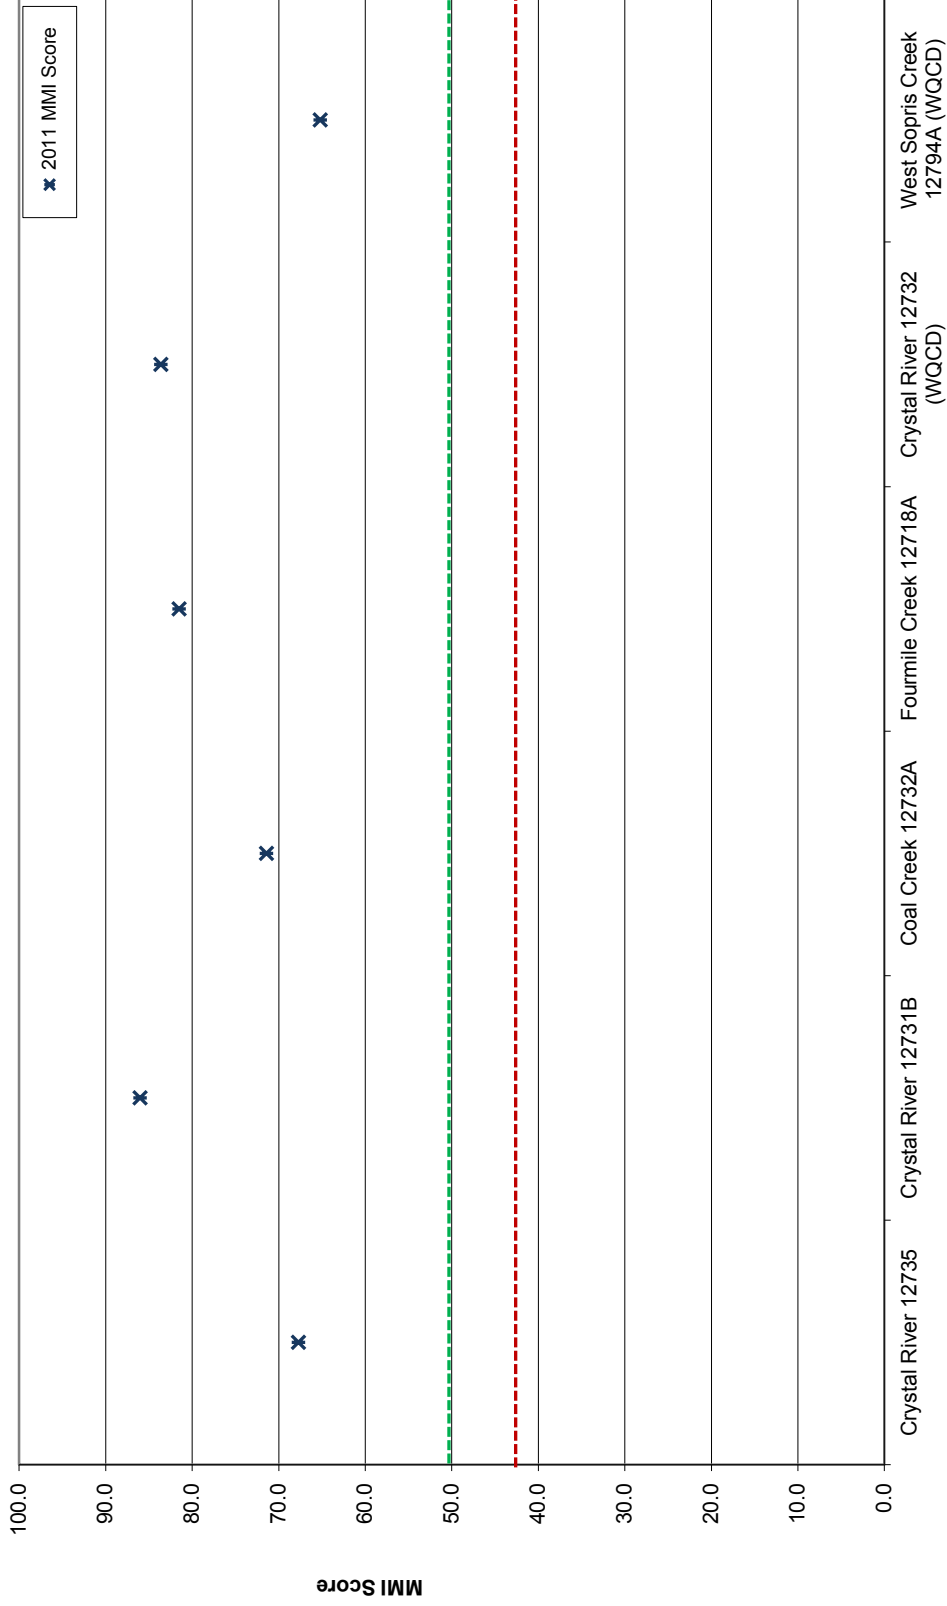
Biotype 2: MMI Scores (Fall 2011)

Figure 4: MMI scores for sites in Biotype 2. The threshold for aquatic life use attainment is represented by the green dashed line, and the threshold for impairment is represented by the red dashed line.

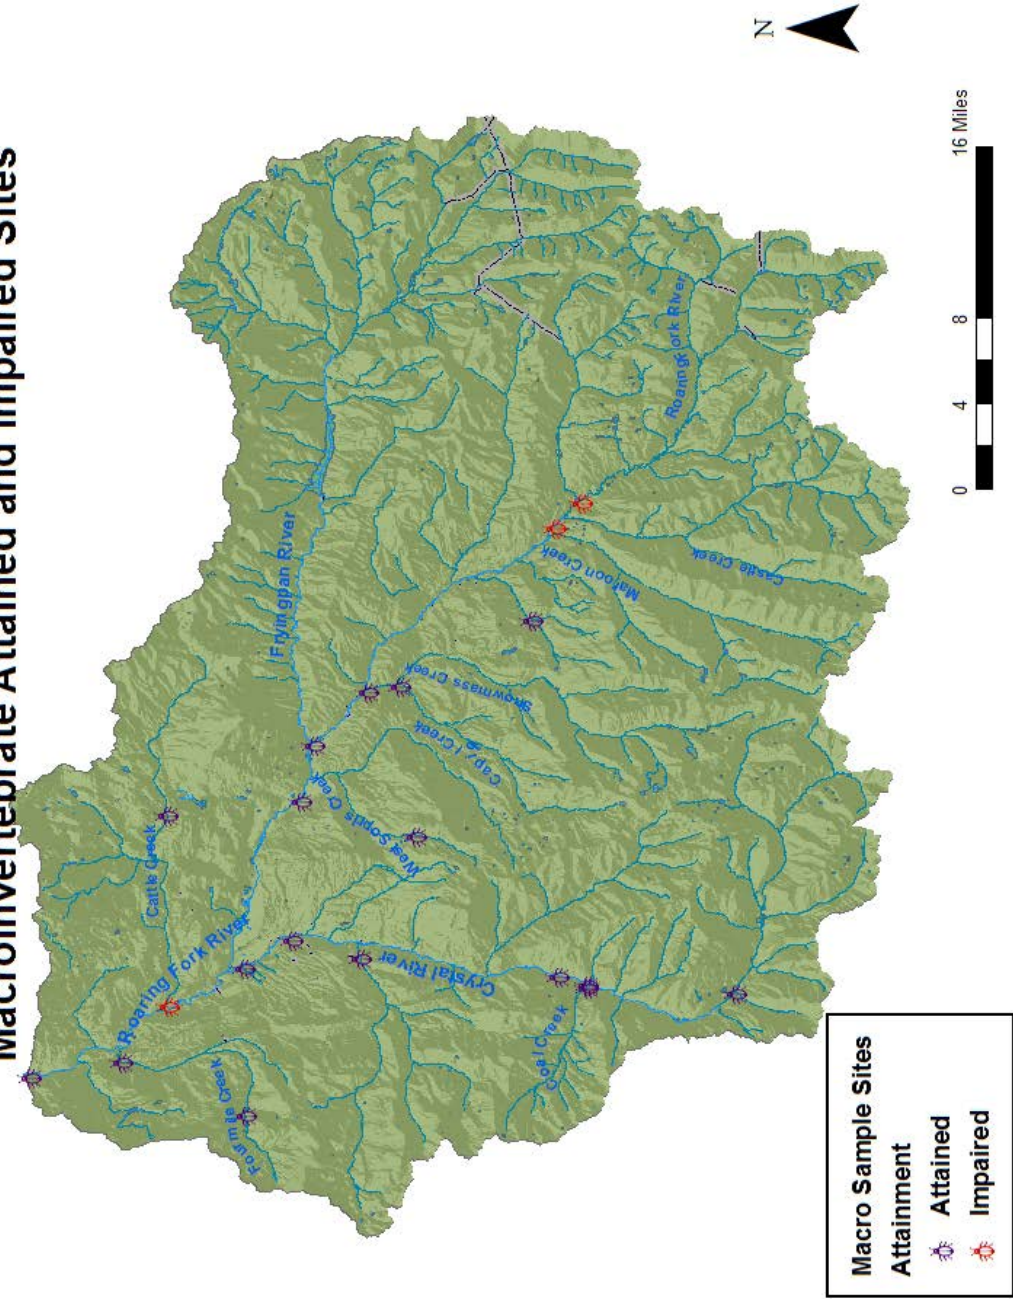
Roaring Fork Watershed Macroinvertebrate Attained and Impaired Sites

Figure 5. 2011 Macroinvertebrate Study Results.

This assessment of stream health found that most streams sampled in the Roaring Fork Watershed met or surpassed the MMI standards for healthy aquatic conditions. Of the twenty sites sampled, only two sites are considered impaired (Cattle Creek site 12719 and Roaring Fork site 12783) while one site (Roaring Fork site 12784) fell in the gray area between healthy and impaired. The highest MMI score in biotype 1 was registered at Thompson Creek (site 12799c), a tributary to the Crystal River, and the second highest score occurred within upper Cattle Creek (site 12725). In biotype 2, the highest MMI score was recorded at the Crystal River (site 12731b). These sites contained some of the best aquatic conditions for macroinvertebrates, a good indicator of overall stream health.
