Drought-Year Baseflow Monitoring on Select Reaches in the Roaring Fork Watershed.

February 13, 2013

S.K. Mason Environmental LLC
856 Colorado Avenue
Carbondale, CO 81623

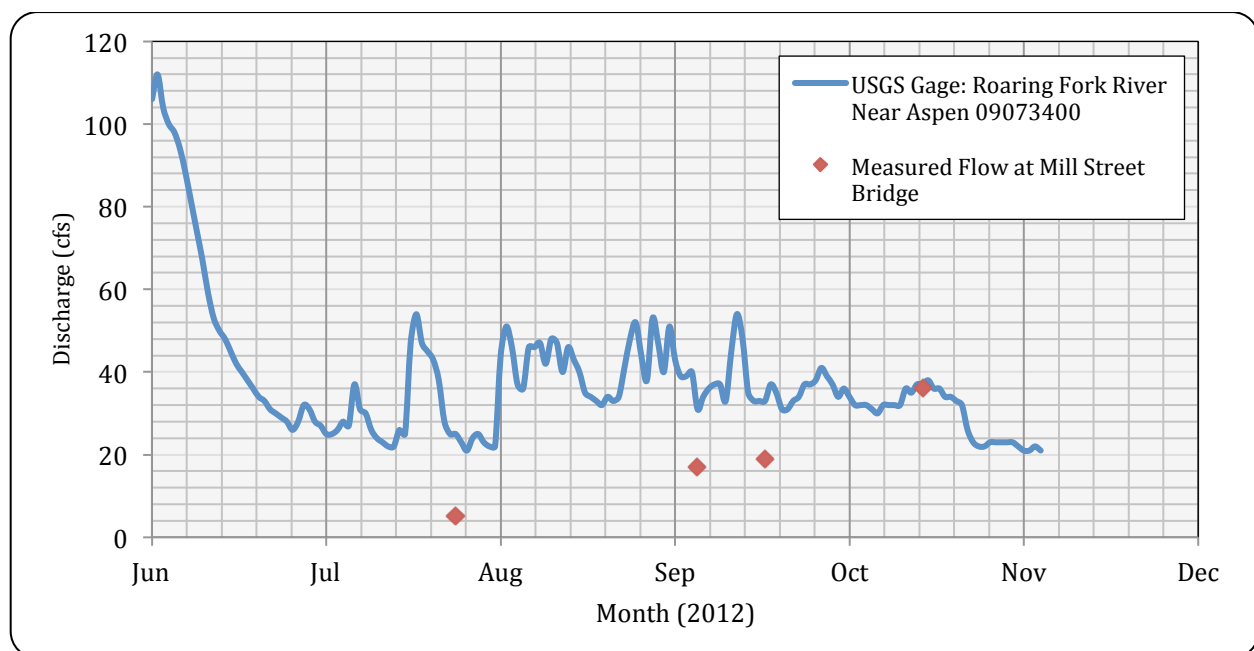
Figure 2. This hydrograph displays the under-estimation of Roaring Fork flows at the Mill Street site during late summer and fall. The last data point records flows after large diversions immediately below the USGS gauge site have ceased for the season. The USGS gauge accurately estimated discharge on the lower river segment on the last data collection date.

The USGS gauge *09073400* is located just upstream of significant local water diversions at the Salvation, Nellie Bird, and Wheeler ditches. Flows measured at the gauge thus overestimate the volume of water flowing through the City of Aspen at any given point in time. The next downstream gauge, *CDWR ROABMCCO*, is sited near the Airport Business Park below the confluence of both Castle and Maroon Creeks. Flow measurements at this site are dominated by these large tributary inputs giving a deceptively robust picture of Roaring Fork River streamflow in the upstream reach. Direct comparison of observed streamflow data collected at Mill Street with the data collected by USGS gauge *09073400* allowed for quantification of the actual discrepancies between the two locations (Table 1, Figure 2).

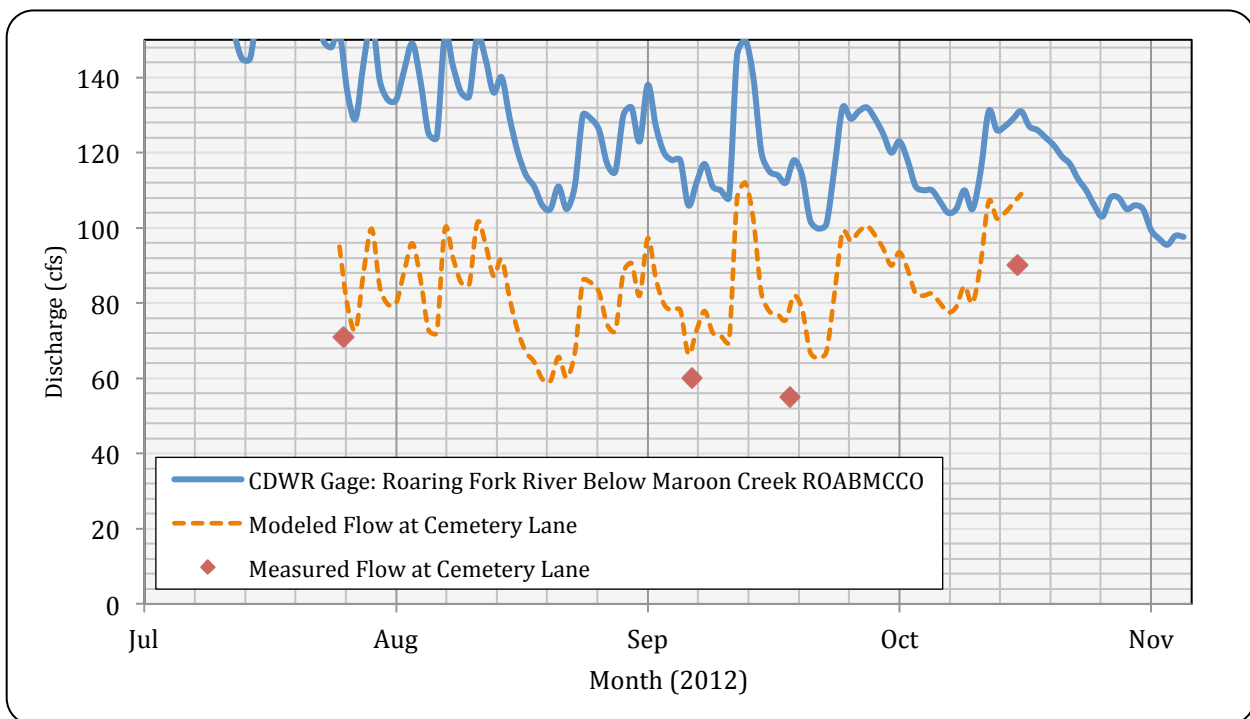
Figure 3. Observed and modeled streamflow at Cemetery Lane. Real-time streamflow data recorded below the confluence with Maroon Creek at a CDWR gauge plotted for reference.

Results show that inclusion of data from Maroon Creek in a subtractive model greatly improves estimates of flow on the Roaring Fork near Cemetery Lane; however, actual streamflows are still overestimated by the model (Table 2). The discrepancies observed between modeled and observed data may arise from the over-simplistic model construction (e.g. some tributary or groundwater inflows/outflows may remain unaccounted for) or may be exaggerated by the sparse nature of the observed data points. The source of the error will be difficult to determine without streamflow data from Maroon Creek of enhanced temporal resolution.

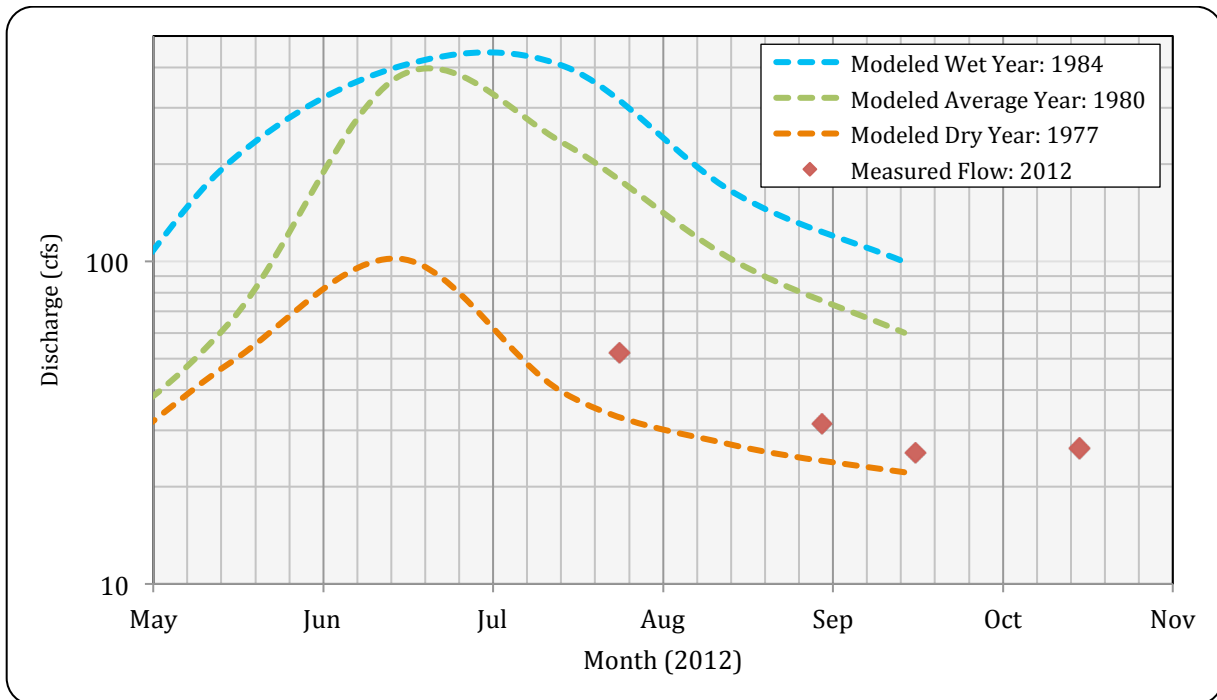
Figure 5. Measured and modeled streamflow for Maroon Creek.

The analysis presented here compares manually measured flows to the City of Aspen's estimated flows for a representative 'dry' year. Modeled data provided by the City of Aspen forms the basis for the hydrographs presented in Figure 5 (Response to Information Request Letter, 2012). Modeled 'dry' year flows provide useful context for the 2012 observations, while the new data simultaneously serves to cross-validate model performance. While a rigorous statistical comparison of measured and modeled flows is both beyond the scope of this report and prohibited by the sparse data available here, a qualitative interpretation of results suggests a good model fit to the data for a representative 'dry' year. Conclusions regarding model accuracy may vary depending on whether 2012 is characterized as drought-year outlier, or representative of 'average' conditions in the face of climate shifts in the southern Rockies favoring drier weather patterns. More data collected across a range of streamflow conditions on upper Maroon Creek will both provide further information to calibrate and validate streamflow models for the watershed, and will help resource managers understand the way that changing climate conditions affect trends in watershed yields, hydrograph timing, and resultant impacts on resource use plans and the ecological function of the stream.

In the face of climate change, it is unclear to what extent the modeled hydrographs produced by the City of Aspen for the CCEC study and the estimated annual water yield for Maroon Creek continue to accurately represent flow conditions Maroon Creek (Figure 5). Because the Maroon Creek watershed remains essentially undeveloped above the T-Lazy 7 Ranch, it serves as an important regional reference for water quality, natural flow regimes, and potential trends in watershed yield from climate change in the Southern Rockies. Continued discharge observations on Upper Maroon Creek may help inform management questions surrounding these issues on Maroon Creek.

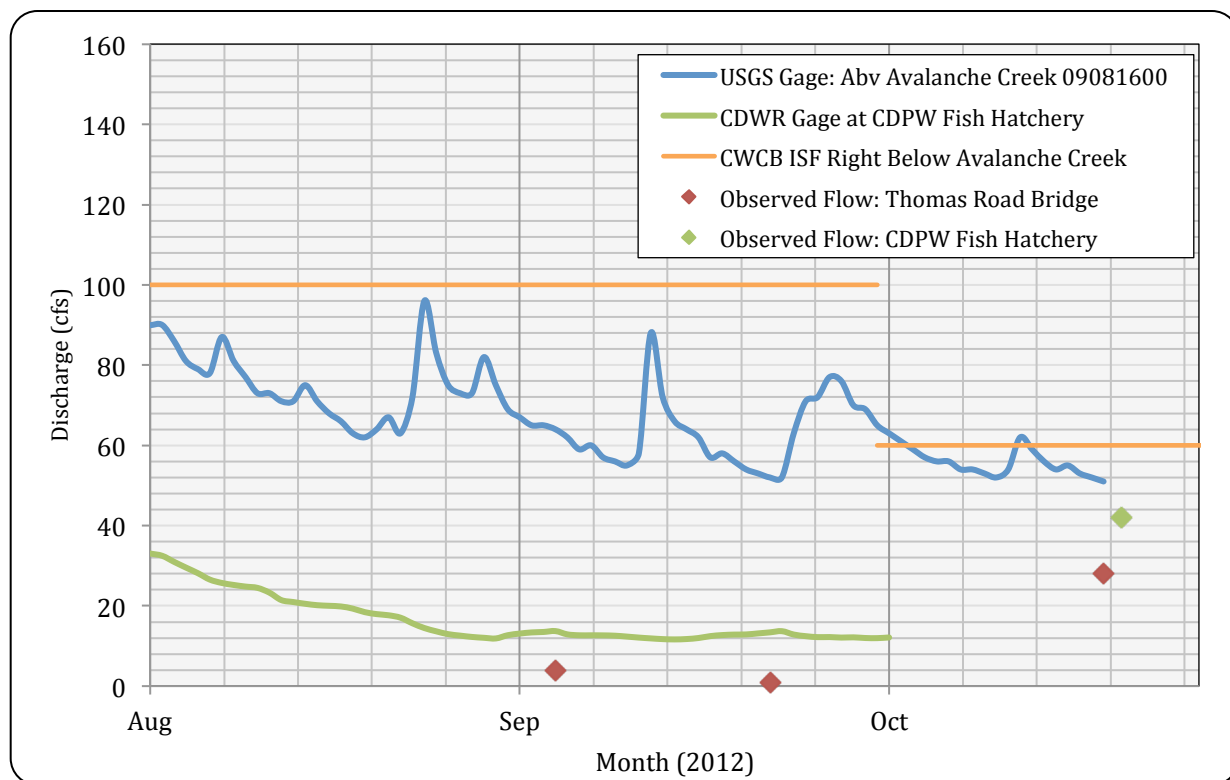
Figure 7. Measured streamflow on the Crystal River at three locations: Avalanche Creek, Thomas Road Bridge and the CDWP Fish Hatchery.

Data collected at Thomas Road site indicate that the CDPW fish hatchery site does not accurately characterize the magnitude of upstream flow depletion; however, it does appear to adequately characterize

general patterns in hydrograph timing. Thus, collection of streamflow data from the Thomas Road site may better illustrate the severity of flow depletions on the Lower Crystal River.

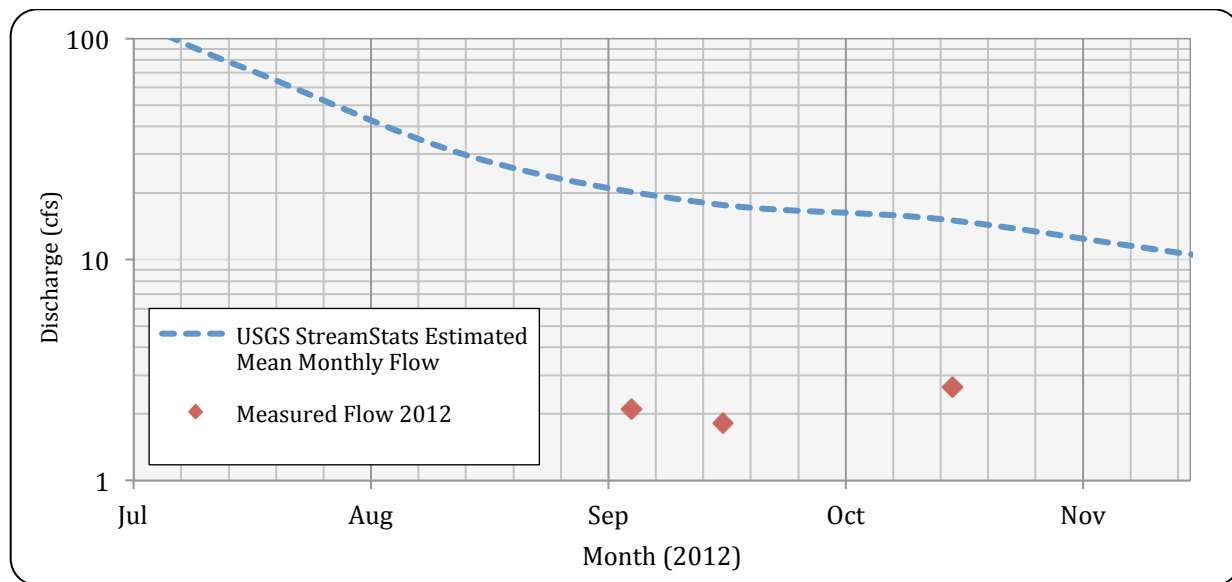
Figure 9. Observed and modeled streamflow for Coal Creek.

generate mathematical relationships for estimating flow parameters in similar, ungauged locations. StreamStats generated three statistics related to modeled low flow conditions at the drainage point corresponding with the measurement location used to collect the 2012 data. The generated statistics include the M7D10Y, Q9, and Q10. M7D10Y represented the 7 day average low flow corresponding to an event with a one in ten year return interval. The Q9 and Q10 statistics estimated the mean monthly flows for September and October. While 2012 flows were well below the estimated mean produced by StreamStats (which has a significant error range), they compared reasonably well to the 10 year low flow estimate of 1.26 cfs.

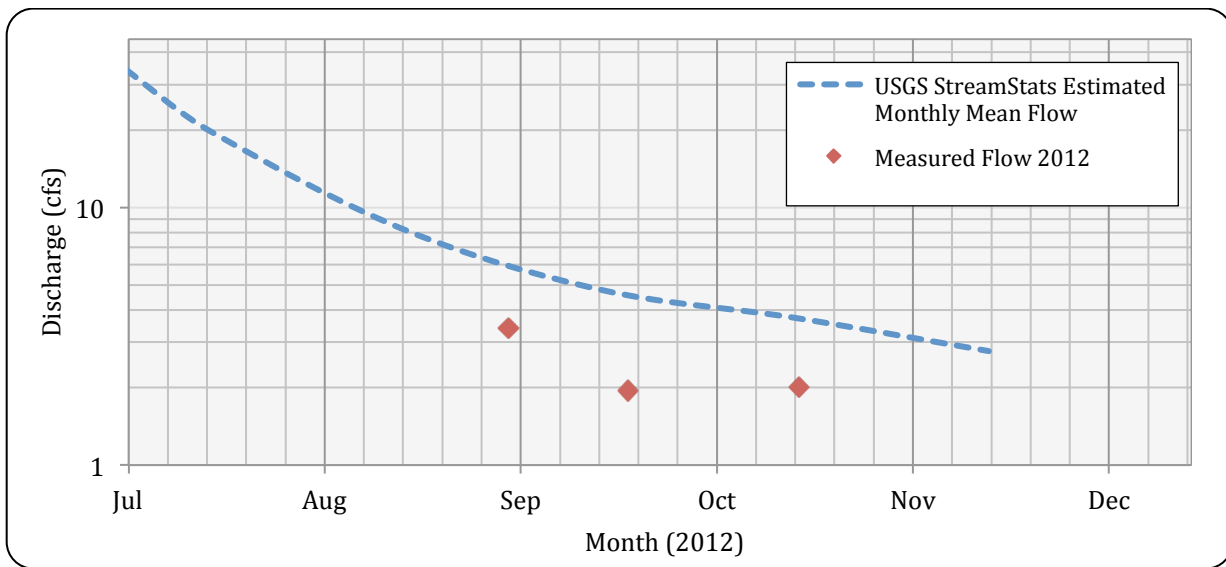
Figure 11. Observed and modeled streamflow for Brush Creek.

regression models like StreamStats have limited utility in watersheds like Brush Creek, due to the confounding effects of human ‘plumbing’ of the stream and river systems. StreamStats generated three statistics related to modeled low flow conditions at the drainage point corresponding to the measurement location used to collect the 2012 data. The generated statistics included the M7D10Y, Q9, and Q10. The M7D10Y statistic represents the 7 day average low flow corresponding to an event with a one in ten year return interval. The Q9 and Q10 statistics estimated the mean monthly flows for September and October. Measured flows compared reasonably well to the estimated monthly mean streamflows, although flows were consistently over-estimated by the model. Observed streamflows were much greater than the M7D10Y statistic (i.e. the estimated 10 year low flow) of 0.27 cfs. Possible explanations for this result include both the large model estimation error and the fact that Brush Creek receives trans-basin water augmentation which elevates streamflows above conditions expected in drought year.
