2012 Crystal River and Coal Basin Aquatic Life Use Assessment

Summary

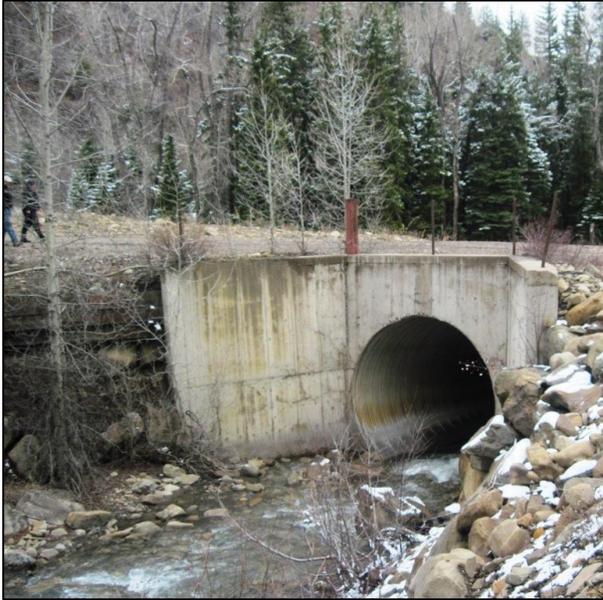
Figure 13. Approximately 1/4 mile downstream of the sampling site on Coal Creek. The actual sampling site had sediment basins on the right bank, approximately 100 feet from the stream, and a coal refuse pile. (USFS, April 2012)

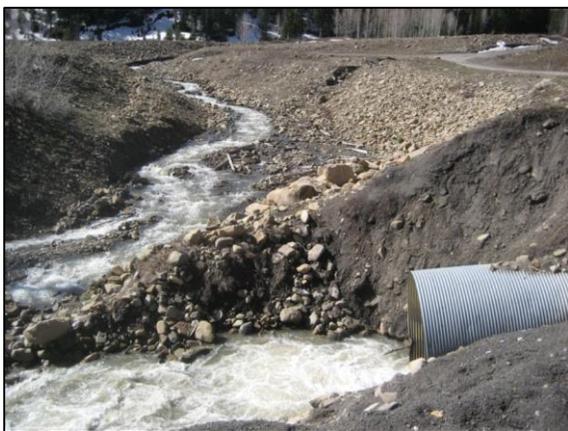
Figure 14. Confluence of Dutch Creek (top) with Coal Creek (right). Sample site is at the top of the photo where the stream bends to the right. (USFS, May 2008)

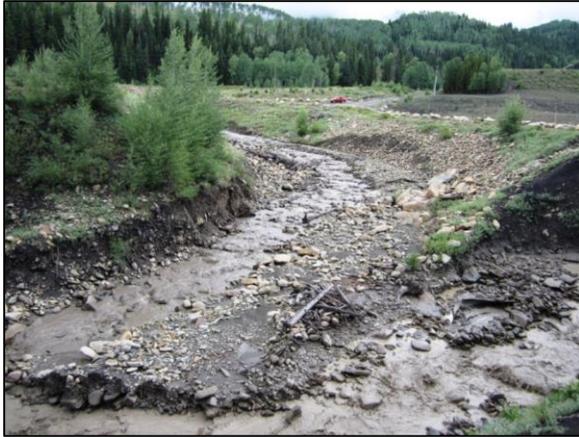
Figure 15. Confluence of Dutch and Coal Creeks during a summer monsoon event. (USFS, July 16, 2012)

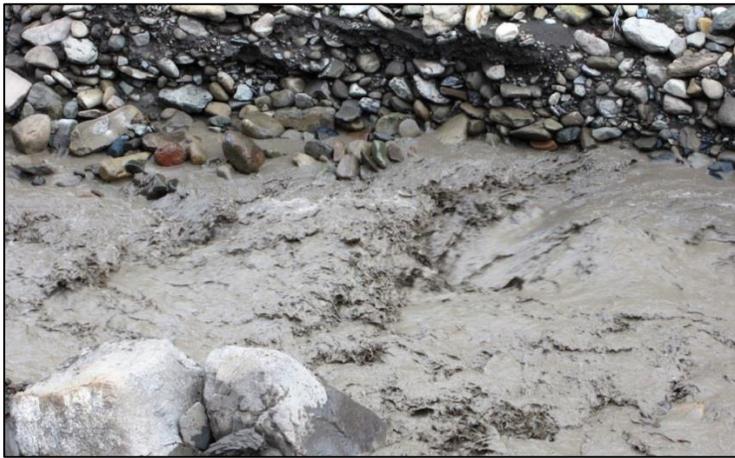
Figure 16. Close up of the same area as the previous photo, capturing the significant sediment load. (USFS, July 16, 2012)

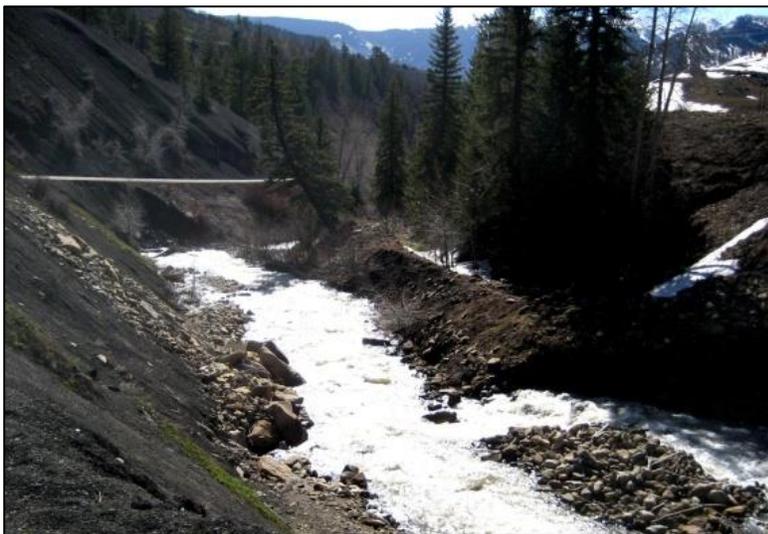
The Coal Creek site downstream of Dutch Creek was located in Biotype 2 and had potential impacts from the historical mining operations on Coal Creek, as well as the previously discussed impacts associated with Dutch Creek. The lowest MMI score in the study area occurred at this site (18.9), indicating impairment for aquatic life use in 2012 (*see Table 5*). Auxiliary metrics included in the MMI analysis indicated that community balance (measured by Diversity) was impaired, while the HBI value (5.04) was near the threshold for impairment (*see Table 5*). Metrics designed to measure sensitive taxa (EPT and Insect Taxa), along with specialized taxa (Clinger Taxa), were also relatively low and provided additional evidence that the macroinvertebrate community at this site was impaired. The visible sedimentation, lack of topsoil/vegetation, and historical mining operations were likely the top contributors to aquatic perturbation at this Coal Creek site in 2012.

Figure 17. Coal Creek looking downstream. Dutch Creek enters from the right side. Coal refuse and a road are located on the left side. Coal refuse is also seen on the right side of the photo. (USFS, May 2010)

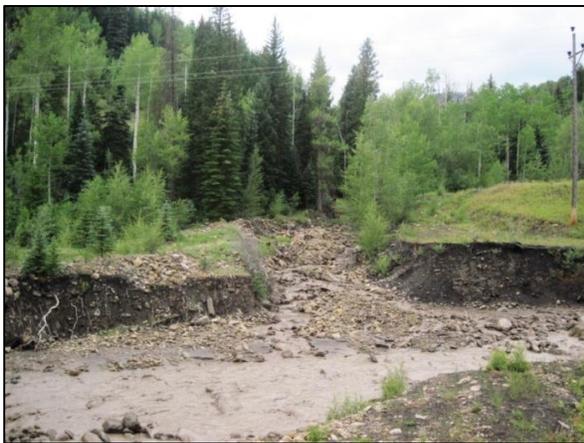
Conditions at the Coal Creek site downstream of the confluence with Bear Creek have been influenced by extensive channelization, historical mining operations, and sedimentation occurring upstream, as well as localized impacts from the bridge removal and construction that occurred in the fall of 2012. This site was located in Biotype 2 and produced an MMI score (32.9) indicating that aquatic life use was impaired in 2012 (*see Table 5*). Metrics designed to measure community balance (Taxa Richness and Diversity), sensitive taxa (EPT and Insect Taxa) and specialized habits of macroinvertebrates (Clinger Taxa) suggested there was a similar level of stress at this site compared to upstream sites on Coal Creek. The relatively low HBI value (4.07) produced at this site suggested that nutrient-enrichment was probably not a major stress contributor in the fall of 2012 (*see Table 5*). Most individual metric values and the MMI score suggested that macroinvertebrate communities at Coal Creek downstream of Bear Creek reflected continued impairment due to anthropogenic impacts (mining, construction, channelization, etc.) in the fall of 2012.

Figure 18. Bear Creek confluence with Coal Creek during a summer monsoon event. (USFS, July 2012)

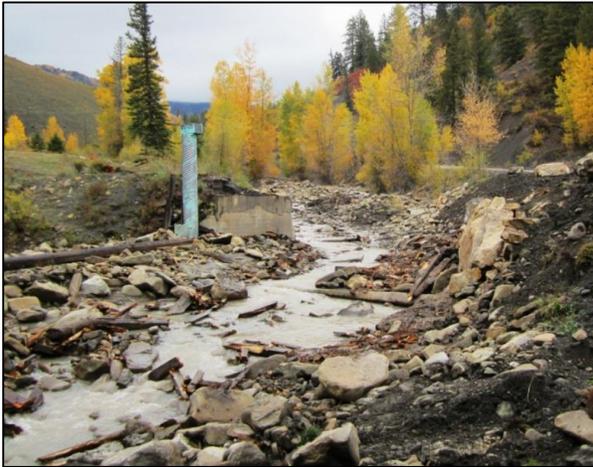
Figure 19. Coal Creek downstream of Bear Creek, looking upstream at the old bridge and stream gage site. The sampling site is at the top of the photo. (USFS, September 2012)

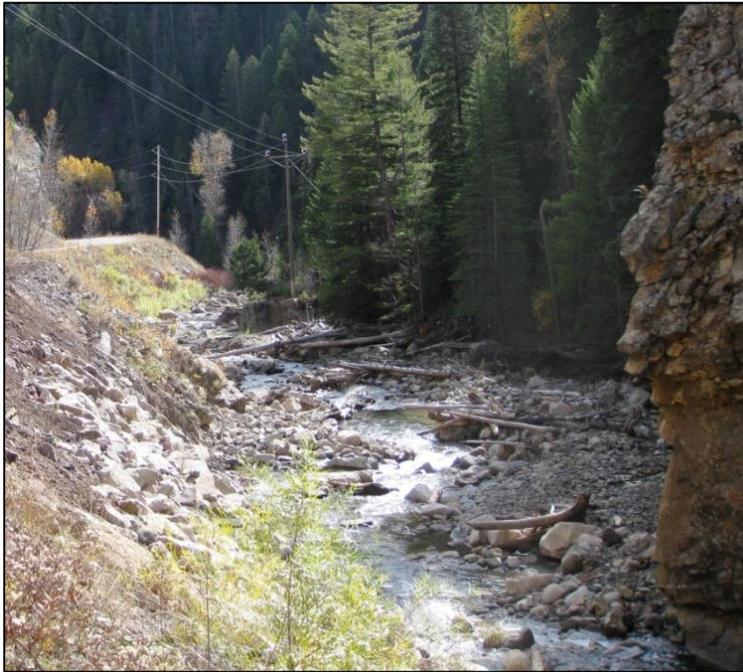
Sedimentation may have been a dominant source of site perturbation in 2012, based on the Clinger Taxa value (2). Clinger Taxa include macroinvertebrates that require clean substrate and excessive sedimentation often contributes to their absence. Nutrient-enrichment did not appear to be a source of stress in 2012 based on the HBI value (3.45) produced at this Coal Creek site. Results from 2012 macroinvertebrate data analysis suggest that aquatic conditions were moderately disturbed and impaired for aquatic life use at Coal Creek at the lower Forest boundary.

Figure 20. Coal Creek downstream of Braderich Creek - one mile upstream of the National Forest boundary. This is not the exact sample site, but the in-channel habitat is similar. (USFS, October 2012)

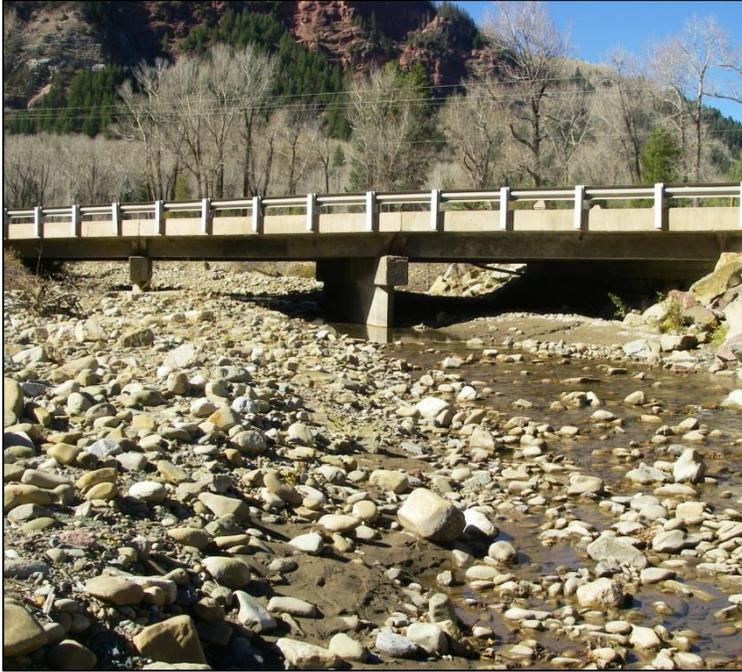
Figure 21. Coal Creek looking upstream. On the upstream side of the bridge the channel is highly modified, significantly down cut and no longer interacting with the floodplain or lower terrace. (RFC, October 2012)

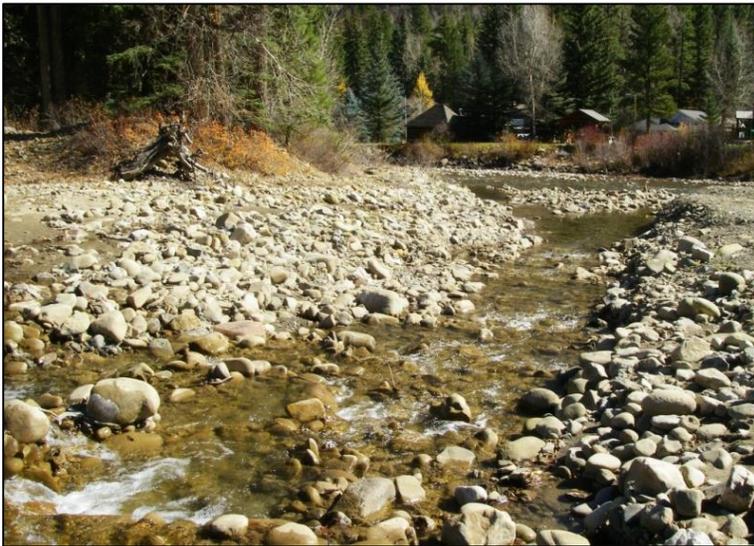
Figure 22. Coal Creek looking downstream at the Crystal River. (RFC, October 2012)

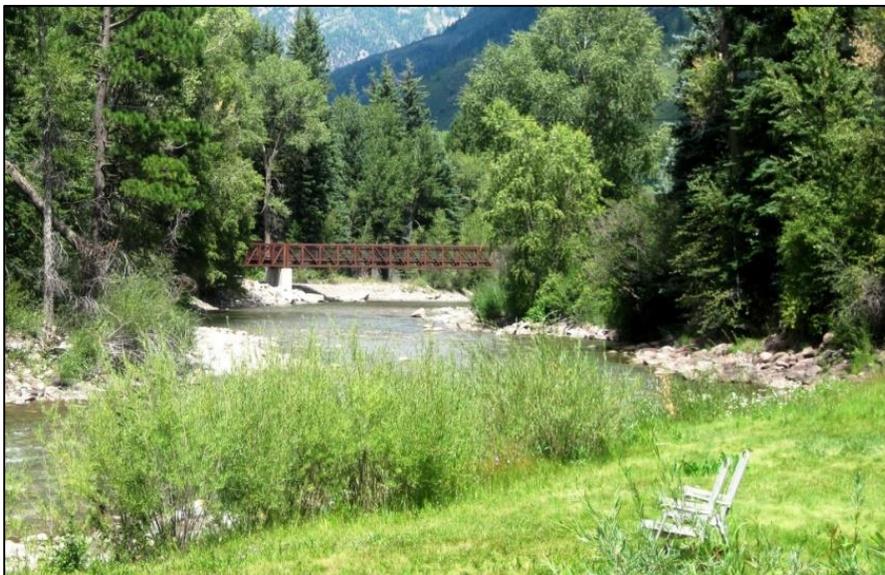
The Crystal River upstream of Coal Creek site was located in a somewhat developed area that was potentially impacted by channelization, lack of riparian habitat, and other stressors associated with the development of the Town of Redstone and Elk Park. This site was located in Biotype 2 and produced an MMI score (56.7) indicating that aquatic life use at this location was above the threshold for attainment in the fall of 2012 (*see Table 5*). Additional metrics applied to the macroinvertebrate data at this site produced values suggesting that the community balance (measured by Taxa Richness and Diversity) was relatively healthy (*see Table 5*). Metrics designed to measure sensitive taxa (EPT and Insect Taxa) and specialized taxa (Clinger Taxa) also produced relatively good values. The HBI value (4.65) was at a level suggesting that nutrient-enrichment was not a major source of perturbation at this site (*see Table 5*).

Figure 25. Sampling site is slightly upstream of the pedestrian bridge. (RFC, August 2012)

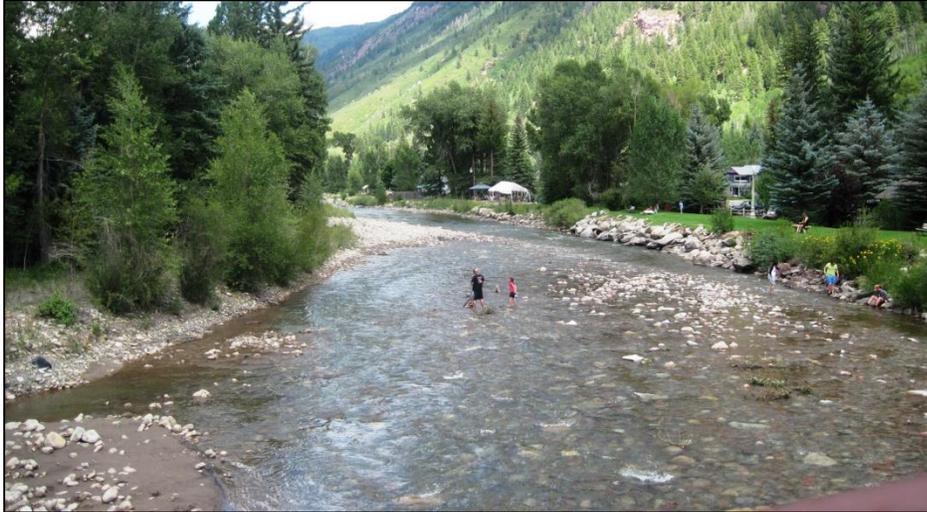
The Crystal River below Coal Creek site had the potential for impacts from the nearby development of the Town of Redstone and the potential for water quality issues associated with receiving water from Coal Creek. This site was located in Biotype 2 and produced an MMI score (65.7) in attainment for aquatic life use (*see Table 5*). Both auxiliary metrics (Diversity and HBI) also produced values (3.15 and 3.79, respectively) above their thresholds for attainment and provided additional evidence that aquatic life in the Crystal River below Coal Creek was not impacted by stress in the fall of 2012 (*see Table 5*). Additional metrics designed to measure sensitive taxa (EPT and Insect Taxa) and specialized taxa (Clinger Taxa) produced values suggesting fairly healthy aquatic conditions. The HBI value (3.79) indicated that nutrient enrichment was probably not a major source of perturbation at this site in 2012 (*see Table 5*).

Figure 27. Coal Creek is on the left. Macroinvertebrates were sampled on the Crystal River between the children and the point bar. (RFC, August 2012)

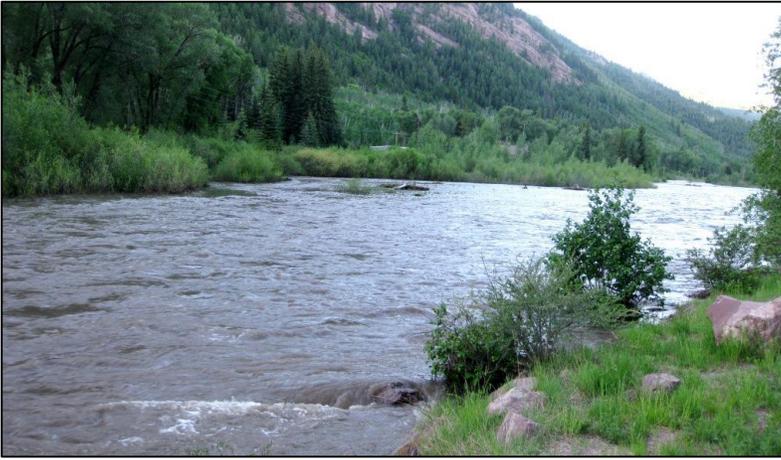
The Crystal River at Fire Station site was located near the Town of Redstone due to its potential to exhibit impacts associated with residential development. The site is located in Biotpe 2 and produced an MMI score of 63.1 in 2012, indicating that it was above the threshold for attainment of aquatic life use (see [Table 5](#)). The analysis of additional metrics also suggested that aquatic conditions were relatively healthy at this site. Community balance (measured by Taxa Richness and Diversity) and numbers of sensitive/specialized taxa (EPT, Insect Taxa, and Clinger Taxa) appeared to be minimally impacted by site perturbations (see [Table 5](#)). The HBI value (3.55) indicated that nutrients were not a major source of stress to macroinvertebrates in the fall of 2012.

Figure 28. Photo taken from the east bank of the Crystal River - looking upstream during spring flow. The sampling site is in the upper right corner of the photo. (USFS, June 2010)
