DIDYMO SURVEY, LOWER FRYINGPAN RIVER, BASALT, COLORADO 2015

Second Annual Report

PREPARED FOR: ROARING FORK CONSERVANCY

PREPARED BY: COLORADO MOUNTAIN COLLEGE
NATURAL RESOURCE MANAGEMENT PROGRAM
TIMBERLINE CAMPUS
901 US HIGHWAY 24
LEADVILLE, CO 80461

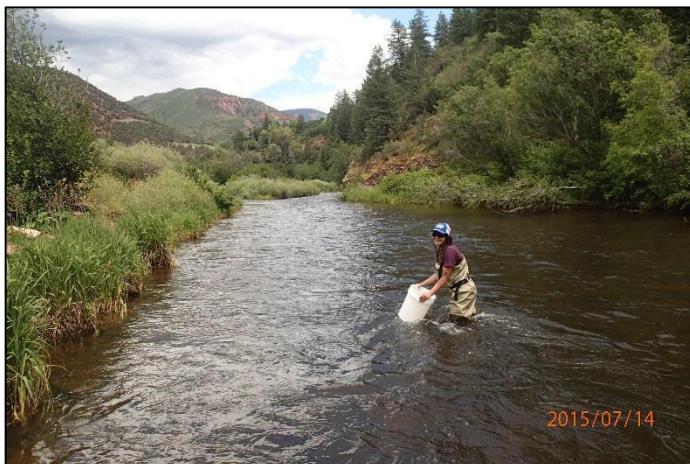
Figure 1. Colorado Mountain College field technicians observing didymo coverage with a gridded viewing bucket

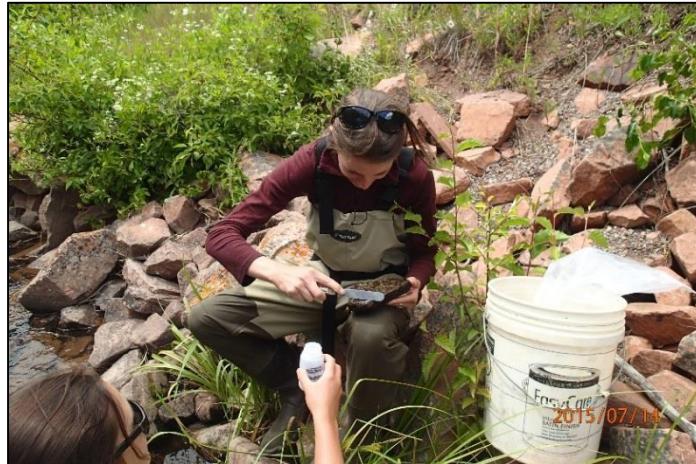
Figure 2. Colorado Mountain College field technicians scraping didymo from a rock to be analyzed in the lab

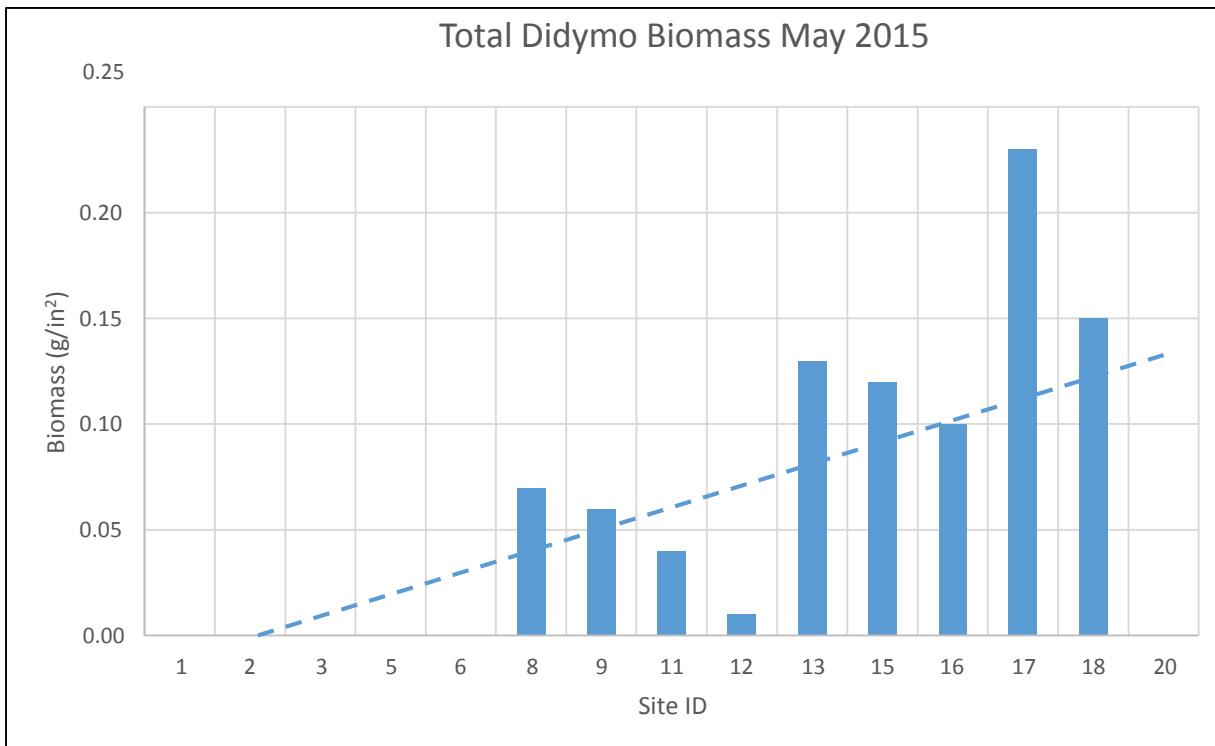
Figure 1. Summary of Didymo Biomass from May 2015 Sampling Event

* Note 2. The dotted line on the graphs for May and July represents the trend of didymo biomass from Site 1 to Site 20.

The mass of didymo per unit area (g/in^2) was measured during the May, July and October 2015 sampling events, represented in Figures 1-3.

In May, didymo presence was concentrated near the tailwaters of Ruedi Reservoir and decreased downstream.

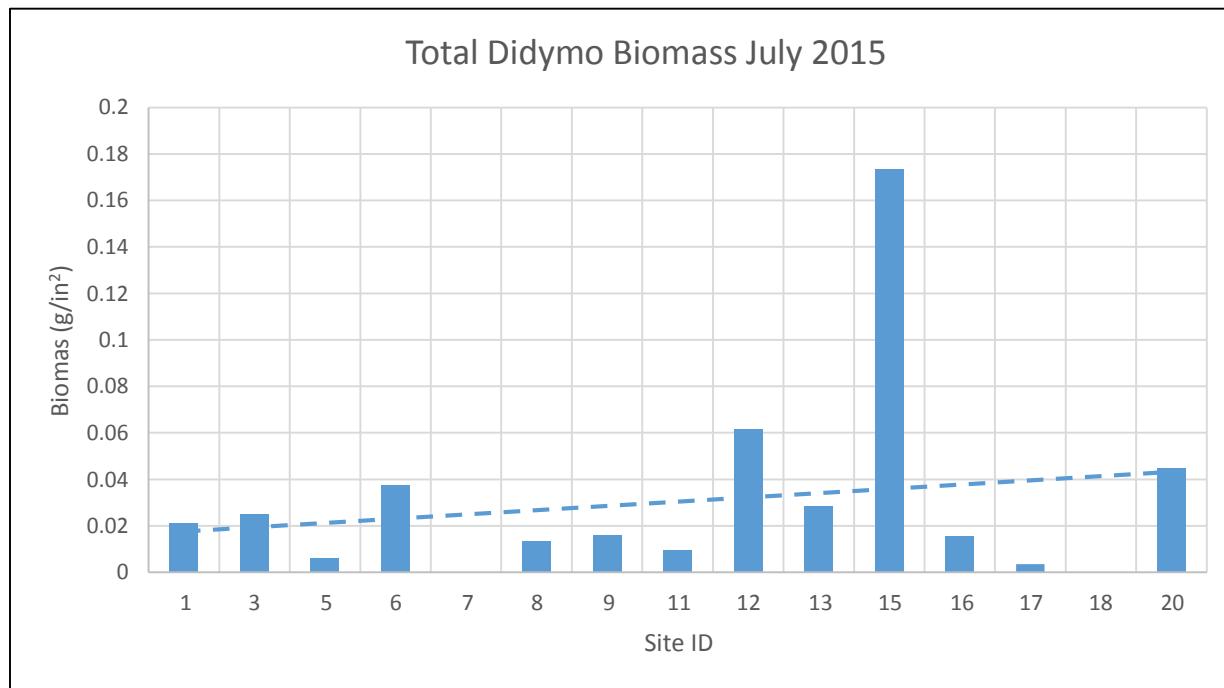
Figure 2. Summary of Didymo Biomass from July 2015 Sampling Event

*Note 2. The dotted line on the graphs for May and July represents the trend of Didymo biomass from Site 1 to Site 20.

In July, didymo was distributed more equally throughout the sample sites, with the highest biomass found at Site 15. Didymo presence at the reference sites increased during the May and July 2015 sampling events compared to the same sampling times in 2014. The high flow event in 2014 was significantly higher in nearby gaged tributaries (USGS 09078475 and 09079450) compared to the high flow event in 2015.

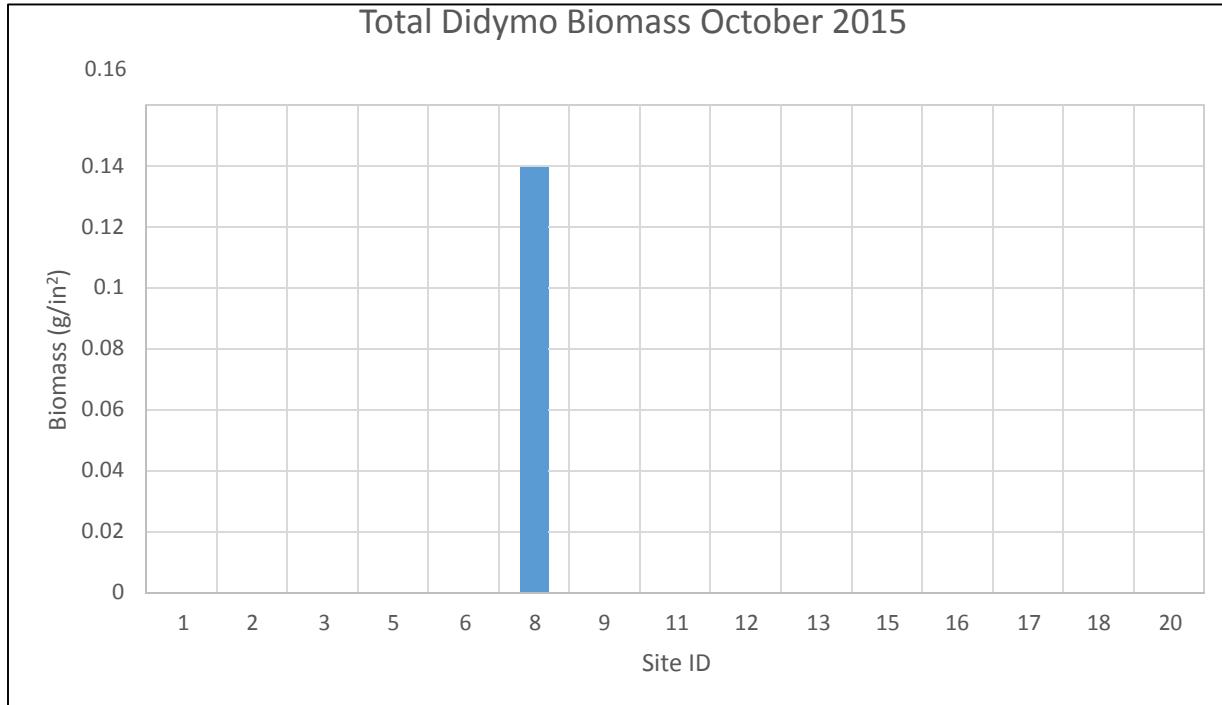
Figure 3. Summary of Didymo Biomass from October 2015 Sampling Event

In October, didymo presence of greater than 5% was observed only at Site 8. The biomass of didymo at Site 8 increased significantly from July to October, but decreased or remained the same for the rest of the sites. This phenomenon may warrant further investigation if similar trends are documented in the future.
