State of the Roaring Fork Watershed Report 2008

Sponsor: Ruedi Water & Power Authority Lead Consultant: Roaring Fork Conservancy

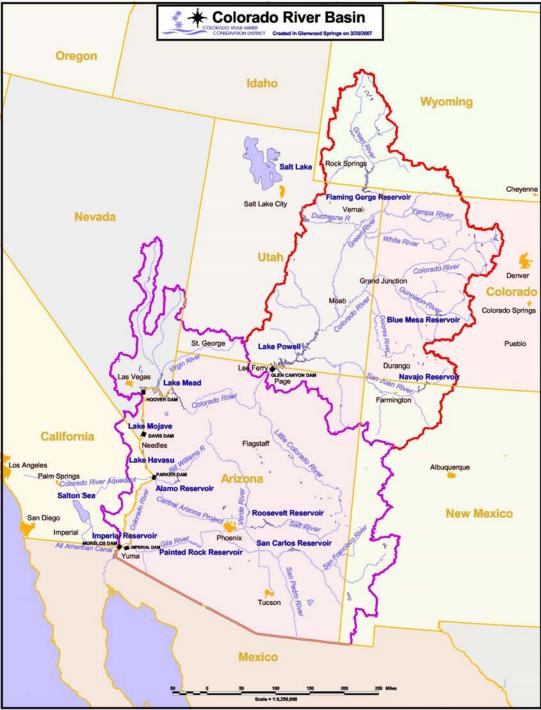
The 1922 Colorado River Compact defined the relationship between what are known as the "Upper Basin states" (Wyoming, Utah, Colorado, New Mexico), where most of the river's water supply originates, and the "Lower Basin states" (Nevada, Arizona, California), where most of the water demands were developing during the early part of the 20th Century (BOR No date a) (Figure 2.3). The 1922 Compact divides the Colorado River Basin into an upper and a lower half, with each having the right to develop and use 7.5 million acre-feet (maf) of Colorado River water annually. In order to meet this obligation, the Upper Basin states must deliver 75 maf every 10 years to the Lower Basin states, as measured at Lee's Ferry, 15 miles downstream from Glen Canyon Dam.

Figure 2.3. Colorado River Basin map showing the Colorado River Compact designated "Upper Basin" and "Lower Basin". Source: <u>http://www.crwcd.org/media/uploads/How_Much_Water_05-15-07.pdf</u>.

The 9,394 foot-long Busk-Ivanhoe Tunnel (Figure 2.3) was a railroad tunnel that was converted to a highway and, since 1962, used for a transmountain diversion. In 1988 Aurora and Pueblo purchased the Busk-Ivanhoe Project. The Busk-Ivanhoe Project collects water from Ivanhoe Creek and historically has delivered it through the Busk-Ivanhoe Tunnel to Turquoise Reservoir. The water rights for the project are slightly senior to those of the Fry-Ark Project and are decreed for 120 cfs. The average annual diversion between 1974 and 1991 was 5,870 acre-feet per year, and the capacity of the Busk-Ivanhoe Tunnel is approximately 300 cfs (CWCB and CDWR, 2007b). However, due to the failure of several sections of the tunnel, the current capacity is limited to about 50 cfs through a 30-inch steel pipe installed on the floor of the tunnel. In order to make up for some of the lost capacity, Pueblo has contracted with BOR to take deliveries of a portion of the Busk-Ivanhoe Project diversions through the Boustead Tunnel. In addition, Aurora and Pueblo have contracted with the BOR for 10,000 acre-feet of storage in Turquoise Reservoir.

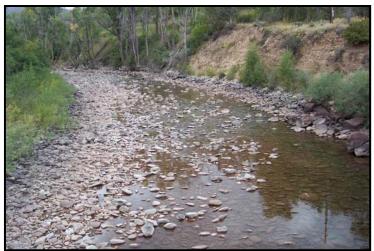
Major consequences can arise from not having enough water in a stream. These consequences are often highly visible, such as water rights not being met, a dewatered stream reach (Figure 3.1.1), or, in extreme cases, dying fish. Flood flows that exceed streambed capacity can also have noticeable consequences, like threats to human safety and property. These flows also have benefits, because they maintain healthy creeks and riparian areas, recharge the groundwater that contributes to stream base flow, and provide water for wells. According to a 2007 Pitkin County Community Survey, 94 percent of all homeowners said that maintaining good stream flows for aesthetic purposes, recreation, and support of fish and wildlife was beneficial (http://www.surveyco.org/Pitkinpdf/2007PitkinCountySpreadsheetsp.pdf).

Figure 3.1.1 Lower Crystal River, September 2, 2004.

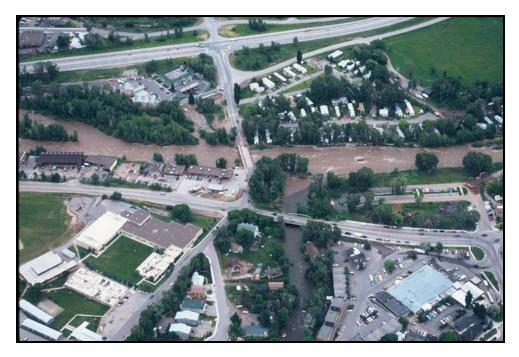
Figure 3.1.14. Downtown Basalt during Spring, 1995 Flood (Source: unknown).

The high flows in 1995 resulted in bank erosion and channel migration throughout the Roaring Fork Valley, leading to damage to property, infrastructure, and river corridor habitat. In 1996, state legislation (Senate Bill 96-153, Section 7) was approved to conduct the Roaring Fork and Fryingpan Rivers Multi-Objective Planning Project (Multi-Objective Study) (BRW, Inc. et al., 1999) to evaluate channel instability. After flooding of the Roaring Fork River in 1995, landowners realized that poorly designed and sited channelization structures often contributed to channel instability. Local residents and governments identified the need to take a more holistic view of river health, stability, and management. Channel instability on the Roaring Fork River has led to:

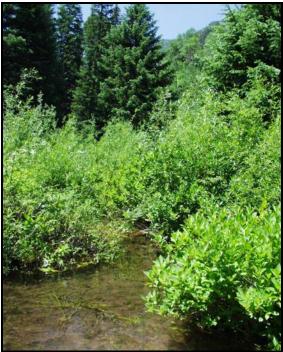
An important function of riparian areas is helping to sustain stream flows. Together, riparian vegetation and soil act as a sponge, soaking up flooding flows (thereby reducing flooding) and later releasing that stored water into the stream (Figure 3.3.9). Water stored in soil is discharged back into the stream during late summer and early autumn, and is essential to maintaining sustainable stream flows. Increased infiltration occurs (percolation of rain, melting snow, or out-of-bank stream flow into soil) due to the physical interception and slowing of runoff, which allows more time for porous soils to soak up and store water. Plant roots increase infiltration by improving soil porosity, which enables more precipitation runoff and out-of-bank flow to soak into and be stored by soil. Soil porosity is also increased by organic matter from riparian vegetation (leaves, decaying logs, and, especially, decaying roots), which improves infiltration and water storage.

Figure 3.3.9. Riparian areas on Maroon Creek soak up out-of-bank flows, replenishing soil moisture and nutrients.

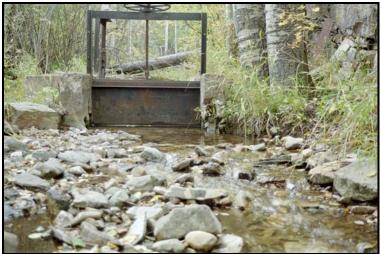
Major human activities causing hydromodification include channel modification, streambank disturbance, and dams. These changes to stream ecosystems can result in altered flows, increased sedimentation, higher water temperatures, decreased oxygen levels, degradation of stream habitat structure, loss of fish and other aquatic and terrestrial populations, and water quality degradation due to increased levels of nutrients, bacteria, pesticides, hydrocarbons, and metals (USEPA, 2006b). Alteration of the natural flooding regime also contributes in a major way to hydrologic modification. As noted earlier, flooding is the primary disturbance factor in stream ecosystems (Saldi-Caromile et al., 2004) and is vital to maintaining channel structure and function. Flooding maintains channel capacity and a natural channel shape with diverse aquatic habitat, and flushes excess sediment from riffles and pools. Dams and diversions reduce flows (Figure 3.4.13), resulting in less frequent and lower magnitude floods.

Figure 3.4.13. Stream diversion on West Sopris Creek, September 9, 2006.

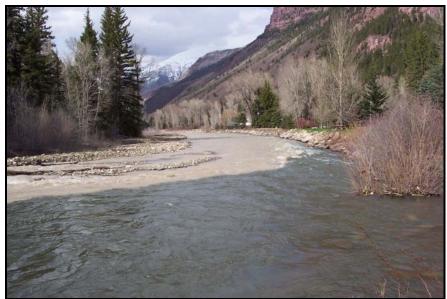
Historic and current mining activity in the watershed is less extensive than in other areas of Colorado, and, consequently, has had considerably less impact than other types of development. However, the legacy of the mining boom of the late 1800s persists and continues to impact instream areas in parts of the watershed. Placer mining destabilizes streambeds. Aggregate mining, if in the stream, alters stream structure, gradient, and suspended load. The practice of lode mining produces toxic mine drainage that impacts stream habitat. Metal and coal mining also directly impact riparian areas with dumps, waste rock, tailings, mill sites, and the installation of tailings ponds and waste disposal sites. These developments can destabilize hillslopes and increase sediment yield to receiving streams (Figure 3.4.14).

Figure 3.4.14. Sediment from Coal Creek entering the Crystal River at Redstone on May 15, 2008.

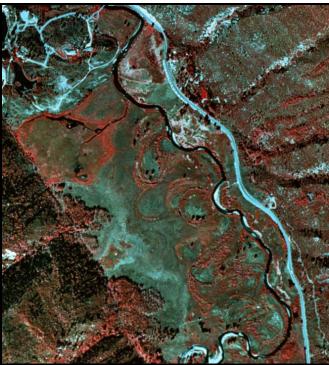
In the lower part of the sub-watershed, glacial action during the late Pleistocene Epoch (ending about 11,000 years ago) formed a wide, low-gradient valley. When the glaciers retreated, they left deep deposits of glacial outwash that are important in determining stream and riparian habitat characteristics. The Roaring Fork Glacier extended down to what is now the eastern edge of Aspen. At the terminal end of the retreating glacier, morainal deposits acted as a dam that accumulated a thick deposit of alluvium consisting of glacial outwash and lake and stream sediments to a depth of more than 300 feet (Hickey et al., 2000). The stream channel developed a highly sinuous pattern due to low gradient and deep deposits of soil. Old meander scars indicate that the stream's historic shape was highly sinuous and that the stream meandered across the width of the valley (Figure 4.1.2). These channel characteristics in combination with native riparian vegetation and beaver activity enabled spring flooding flows to overbank and spread across the riparian zone. Wetlands occurred across much of the valley floor, even where the river historically did not meander due to shallow groundwater discharge from adjacent slopes.

Figure 4.1.2. 1990 Infrared aerial photograph of the historic meander pattern within the North Star Nature Preserve area.

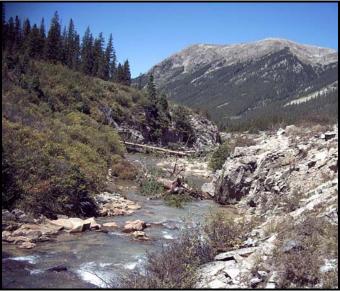
that is reflected in the variety of stream types ranging from wide meadows with beaver ponds to deep, rocky gorges (Figure 4.1.3). Hunter Creek is a hanging glacial valley that drops steeply to meet the Roaring Fork River. Aspen, located near the confluence of Hunter Creek and the Roaring Fork River, sits partly on glacial outwash deposits. The Aspen Mountain Ski Area is located due south of Aspen within sedimentary rocks consisting of dolomite, sandstone, and limestone. This area was identified as a tier-two debris flow zone in "Critical Landslides in Colorado: A year 2002 review and priority list" (Rodgers, 2005). Tier-two listing is very significant but less severe than tier-one.

Figure 4.1.3. Rocky gorge in Lincoln Creek.

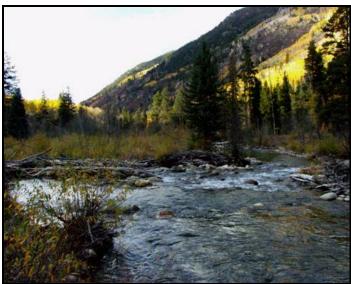
Upland habitat from RF1-1 through RF 3-11 and LM1-1 to LM1-2 is mostly in excellent condition and contributes positively to stream flow and water quality (Figure 4.1.15). Exceptions include those areas impacted by Highway 82 roadcuts, mining roads and un-reclaimed mine sites, recreational trails, residential development, and the Aspen Mountain Ski Area. Roadcuts have resulted in fragmented upland and riparian habitat, and eroding slopes that impact streams

Figure 4.1.15. Upland habitat adjacent to RF3-1 contributes to stream flows, water quality, and wildlife values.

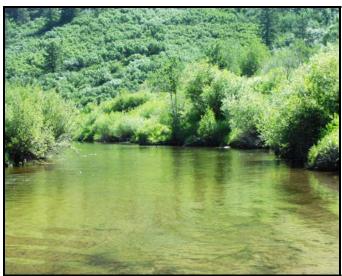
Figure 4.1.20. Riparian vegetation at the James H. Smith open space property (RF3-10) stabilizes the stream channel and provides high quality riparian habitat.

Along stream reach RF3-10, the James H. Smith open space property (Figure 4.1.20), riparian habitat is sustainable because there is a sufficiently wide riparian zone with dense cover, complex habitat structure, and diverse composition of native riparian plant species with a good distribution of all age classes of trees and shrubs. High quality riparian habitat in this reach has diminished the negative impacts of hydrologic alteration by maintaining a stable channel that is not downcut, enabling spring flooding flows to overbank and replenish groundwater.

- The James H. Smith open space property (reach RF3-10) provides an important example of historic channel conditions with optimal sinuosity, intact native riparian vegetation, stable stream banks, and resulting healthy riparian and aquatic habitat. This reach provides an important contrast to the rest of the lower part of the sub-watershed, which generally has been degraded through development activities.

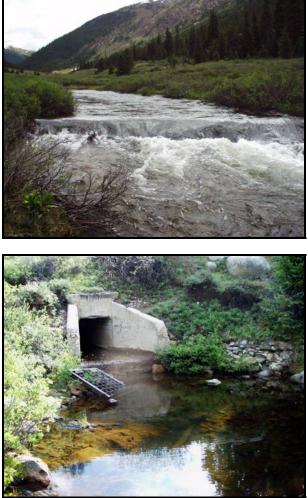
Figure 4.1.23. Upper photo: Lost Man Creek above the dam. Lower photo: Lost Man Creek below the dam. Very little water is left in the stream to maintain the channel or flush sediment from the stream.

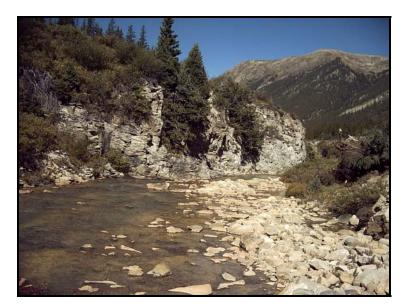
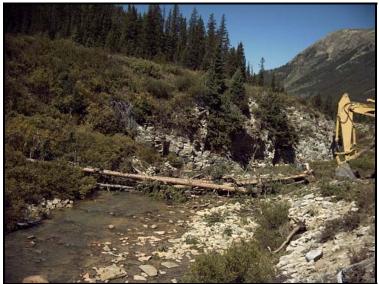
Figure 4.1.24. Large wood replacement project Lincoln Creek, 2004. Upper photo: Before large wood was placed. Lower photo: Wood being placed in stream. Photo credits: Mark Lacy.

Although transmountain diversions that have been in existence since the 1930s pose a major challenge for aquatic species in this sub-watershed, some instream restoration work using large unanchored wood has been done in Lincoln Creek downstream of Grizzly Reservoir (Mark Lacy, USFS Fish Biologist, personal communication, March 17, 2008) (Figure 4.1.24). Beavers are beginning to do some dam building in Lincoln Creek, which will also help maintain complex diverse aquatic habitats. A good example of the dynamic relationships between beaver, wood, and aquatic habitats is found in the upper Roaring Fork River above the old Independence townsite. This site can serve as a reference for restoration activities that can be replicated in appropriate reaches within this sub-watershed and other reaches throughout the entire watershed.

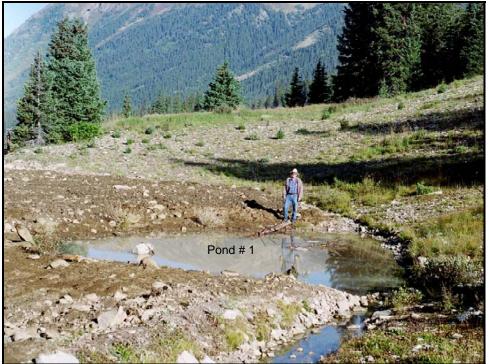
Figure 4.1.25. Boreal toad breeding pond construction in Lincoln Creek, September 2007. Photo credit Mark Lacy.

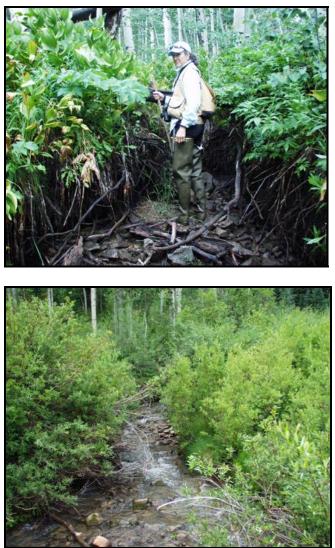
Figure 4.2.13. Reach BR1-1: At the headwaters of Brush Creek, dewatering and downcutting is severe (upper photo). In the lower photo, groundwater slope discharge sustains riparian vegetation. Further downstream in reach BR1-1, enough groundwater has discharged and accumulated in the channel to create sustainable flows.

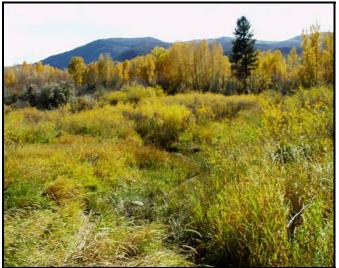
Figure 4.3.8. Riparian habitat at the USFS Tree Farm on the right bank of reach RF5-5 provides good wildlife potential.

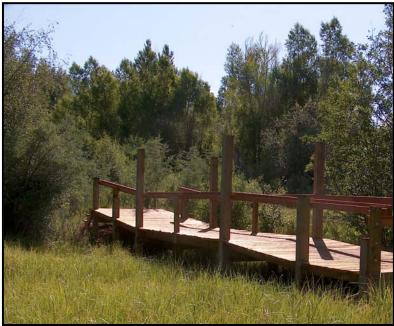
Figure 4.3.9. Boardwalk construction at the USFS Tree Farm to protect wetland habitats (Photo credit: Mark Lacy).

Several studies have assessed biological diversity in this sub-watershed including the Colorado Natural Heritage Program (CNHP), the SHI, and the Roaring Fork Valley Bird Monitoring Project. CNHP identified two riparian Potential Conservation Areas (PCAs) (Figure 3.3.2 and Appendix 3.3.2) because of their biodiversity significance: The Ranch at Roaring Fork (RF5-11), and several reaches on the Roaring Fork near the unincorporated neighborhood of El Jebel (RF5-7, 8, and 9). The Ranch at Roaring Fork was cited as having "one of the largest good condition riparian areas observed in the lower Roaring Fork Watershed," as well as other elements of concern. A globally-vulnerable riparian plant community occurs in the El Jebel PCA (narrowleaf cottonwood/thinleaf alder). This area is referred to as the USFS "Tree Farm" and restoration activities began in 2007 by constructing 90 feet of boardwalk to protect wetland habitats (USFS,

2006) (Figure 4.3.9). Additionally, a great blue heron nesting colony occurs in reach RF5-9. Because great blue herons are known to abandon nests in response to increased human presence, road building, and logging activity, CNHP has recommended a minimum buffer zone of 300 meters (1000 feet.) where no human activity would take place during the heron courtship and nesting season (Spackman et al, 1999), which in this sub-watershed, typically begins in mid-April and extends through the end of July. CNHP also identified noxious weeds and residential and recreational development as threats to both areas and recommended weed control and restricted recreation access to preserve their biodiversity. In 2006 Audubon Colorado designated Spring Park Reservoir as an Important Bird Area, based on its impressive concentrations of migratory waterfowl. Roaring Fork Audubon Society member Linda Vidal, who nominated the site, wrote in the application: "The reservoir is one of the most important migratory stop-over, resting, and feeding sites on the Western Slope" (Roaring Fork Audubon Society, 2007).

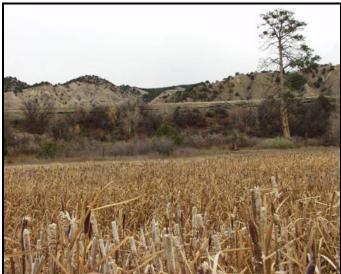
Figure 4.4.10. A cattail marsh receives treated sewage and removes nutrients before flowing into the Roaring Fork River. A great blue heron nesting colony can be seen in the ponderosa pine tree.

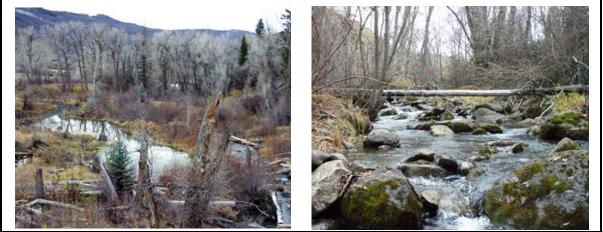
Figure 4.4.16. Beaver pond complexes are present in two areas of reach 4M1-5. Directly below the beaver ponds(right photo) stream flows are restored and riparian habitat is in good condition.

In Fourmile Creek from Sunlight Mountain Resort (reach 4M1-3) to the confluence with the Roaring Fork River, the combined impacts of residential, commercial, and agricultural development have degraded ecosystem functions by reducing both the width and quality of the riparian habitat. In the majority of 4M1-5, road-induced channelization has reduced and sometimes eliminated the riparian zone. Housing and commercial development in 4M1-3 and 1-5 has typically included clearing native riparian shrubs and replacing them with non-native grass lawns. Throughout the drainage, ecosystem functions such as pollution filtration and streambank stabilization are degraded, weed invasion is extensive, and erosion is common. Riparian areas are in better condition where there is beaver activity (Figure 4.4.16).

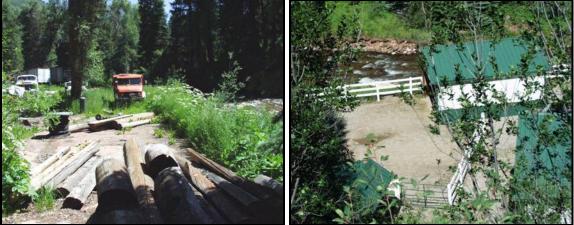
Figure 4.5.10. MA1-2: Left photo: Development in the riparian zone has cleared native vegetation, encouraged the spread of noxious weeds, and has led to destabilized and eroded streambanks. Right photo: MA1-3: Construction of a corral and buildings in the riparian zone has eliminated vegetation, thus reducing habitat value.

While much of the sub-watershed's uplands are within wilderness, a corridor from the White River National Forest (WRNF) boundary in the lower part of the Maroon Creek drainage to Maroon Lake falls under a USFS Management Area Prescription for "Scenery" because of the road to Maroon Lake. The riparian area along the road is managed primarily by default for wilderness values. Only one bridge across Maroon Creek in this section accesses the East Maroon Creek Portal trailhead. Because the stream is deeply and naturally entrenched over much of its length there has been little opportunity for alteration in the riparian zone. Consequently, much of the riparian corridor is undeveloped and in good condition. High quality, unmodified riparian habitat is present on 66 percent of the left bank, 34 percent is slightly modified; and there is no moderately or heavily modified or severely degraded habitat. On the right bank, 81 percent of riparian habitat is high quality and 19 percent is slightly modified. Table 4.5.4 provides a summary of the type and extent of impacts to riparian and instream habitat in the Maroon Creek drainage. In some areas riparian zone width and vegetative bank protective cover and quality are reduced by human land uses. More specifically, these impacts result from vegetation disturbance related to campgrounds and trails in reach MA1-1; a commercial recreation operation and related parking lots, pastures, and corrals in reach MA1-2; and recreational trails, domestic livestock grazing and corrals, and some residential development in reaches MA1-4 and MA1-5 (Figure 4.5.10). Noxious weeds are not common throughout most of

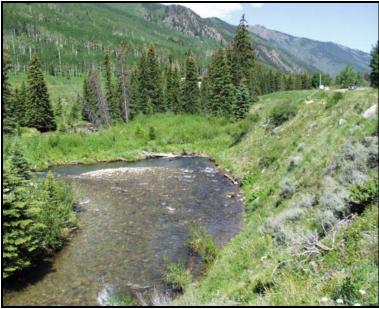
Figure 4.5.16. Along reach CS2-1 a roadcut has destabilized the hillslope causing erosion and excess sediment to move into the stream.

Sponsor: Ruedi Water & Power Authority Lead Consultant: Roaring Fork Conservancy Chapter 4, Section 5, Page 24 stems from erosion in upstream reaches in CS2-5 (Figure 4.5.16). In reach CS1-9, there is natural sediment delivery into Castle Creek.

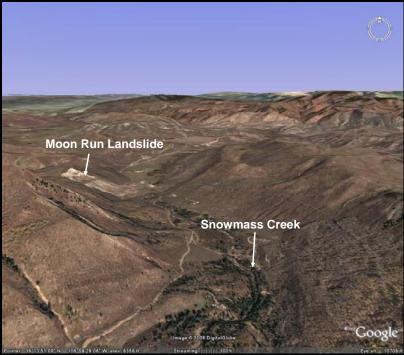
Figure 4.6.1. Moon Run landslide scar (lower left) in the Snowmass Creek drainage (Google Earth image downloaded March 15, 2008).

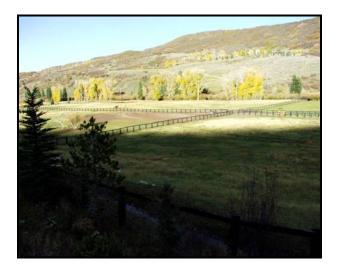
Figure 4.6.13. Upper photo: Riparian willow carrs have been converted into hay meadows. Lower photo: At the bottom of this reach, a small natural area of willow carr habitat remains.

Overall, riparian habitat has been modified and degraded by various types of development including grazing, conversion of native habitat into hay meadows, and residential developments with nonnative grasses (Figure 4.6.13). Consequently, no high quality stream reaches remain in the assessment area. On the left bank, 22 percent of riparian habitat has been slightly modified, 31 percent moderately modified, 23 percent heavily modified, and 24 percent severely degraded; on the right bank, 22 percent of the riparian habitat is slightly modified, 42 percent moderately modified, 12 percent heavily modified, and 24 percent severely degraded. Table 4.6.4 provides a summary of the type and extent of threats to riparian and stream habitat. Vegetation disturbance resulting from recreational trails has degraded 5 percent of streambank habitat in the assessment area. Trail impacts occur primarily on wilderness lands where trail-induced disturbance has damaged 10 percent of streambank vegetation in reach SN1-1, causing subsequent bank erosion in those areas. Snowmass Creek Road parallels the stream along most of the drainage but only occasionally traverses riparian habitat. The road fragments upland habitat, and where it has been built in the riparian zone or bridges cross the streambank, riparian vegetation has been eliminated and banks are destabilized and eroding.

Grazing is common in the riparian zone on stream reaches SN1-1, 1-2, and 1-3 and has resulted in damage to vegetation from trampling, and diminished plant vigor. In stream reaches SN1-5, 1-6, and 1-7, conversion of riparian habitat into hay meadows and pasture is common and has resulted in the clearing of willow carrs from much of the floodplain. Conversion of agricultural lands into housing developments is common and, in some cases, has included the removal of understory shrubs and herbs. Development has diminished plant species diversity, simplified habitat structure, and compacted soils.

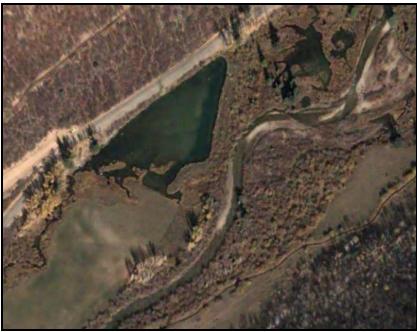
Figure 4.6.15. In the photo's lower left is a constrained channel, resulting from agricultural land use, while the upper right of the photo contains a more natural, braided channel (Google Earth image downloaded March 15, 2008).

Historically, Type C streams (low gradient, meandering reaches) included multiple channels flowing across the floodplain interspersed with beaver dams. The location of these channels frequently changed from year to year, depending upon spring flows and beaver populations. When the valley was settled for agriculture the stream channel was commonly constrained to a single channel, often at the edge of the floodplain, and beaver dams and pools were removed to create pastures or tillable fields (Figure 4.6.15). This made the adjacent lands valuable for agriculture, but has impacted and continues to impact instream habitats and aquatic species. Confining the stream to a single channel has increased stream velocity, causing the stream to downcut and erode the adjacent banks. This bank erosion is caused by the stream's tendency to dissipate energy. If the erosion were allowed to continue, the stream would eventually reincorporate the natural meandering pattern that is normal for Type C channels. However, the issue is often addressed through use of rock or other material on the eroded sections to harden and protect the bank, thus preventing natural stream dynamics from bringing the channel back into balance. If the channel is permitted to flow in a more natural, meandering channel, riparian vegetation will generally protect the streambanks and improve instream habitats. Grazing and development cause additional alteration to these riparian areas, leading to more streambank instability (Figure 4.6.16). As examples, riparian vegetation degradation stemming from grazing in reach SN1-3, conversion to hay meadows in SN1-6, and home development in SN1-7, have led to bank erosion, and lateral and down cutting of the channel. Consequently, the stream in this area has widened and the channel has become straighter. Because of these modifications, no high quality stream reaches remain in the assessment area. Twenty-two percent of instream habitat is slightly modified, 54 percent moderately modified, and 24 percent heavily modified. No stream reaches are severely degraded.

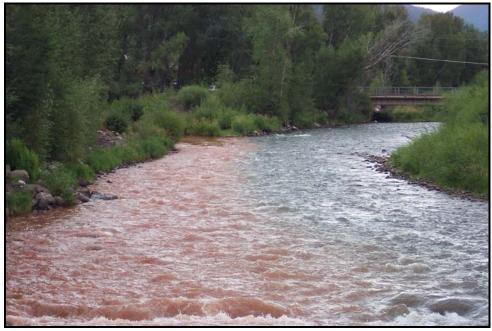
Figure 4.7.7. High sediment input in the Fryingpan River, originally coming from Seven Castles Creek, is seen here joining the Roaring Fork River (August 5, 2007) (Photo Credit: Chad Rudow).

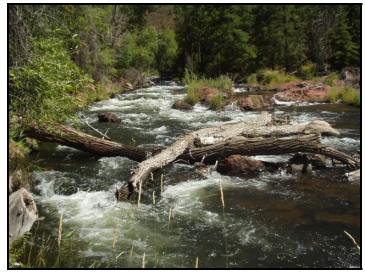
Figure 4.7.8. Large wood accumulations in the Fryingpan River provided complex instream habitat (Photo credit: Kit Davidson) (http://www.americanwhitewater.org/content/Photo_detail_photoid_8521_size_big_).

Both upper and lower portions of the Fryingpan River are listed as boatable by the Southwest Paddler and American Whitewater organizations (Figure 1.11). According to the Southwest Paddler, most boaters only run the last 4.4 miles of the lower river starting at Seven Castles, although the river can be paddled all the way from the Ruedi Dam to the Roaring Fork River with adequate flow. The web site provides this general description about the lower Fryingpan: "This section is more widely known for its trophy, wild trout fishing than as a boating stream, but when the flow is good, LOOK OUT! This can be a very interesting and fun run in Class IV-whitewater" (http://southwestpaddler.com/docs/roaring8.html). Appendix 3.1.6 lists the maximum, minimum, and optimum suggested flows for three sections of the lower Fryingpan River. In fact, the Fryingpan River is rarely navigated and economic activity associated with river boating is negligible. Unpredictable flows, large boulder gardens, and dead fallen trees are identified by Southwest Paddler as impediments to boating. Figure 4.7.8 shows a photo taken from the American Whitewater website, documenting the occurrence of wood in the stream.

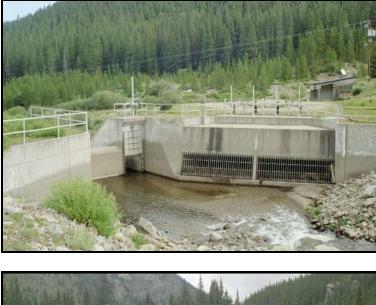
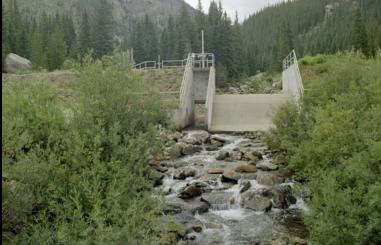
Figure 4.7.9. View of upper and lower ends of Fry-Ark Project diversion structure on Chapman Gulch (August 14, 2006).

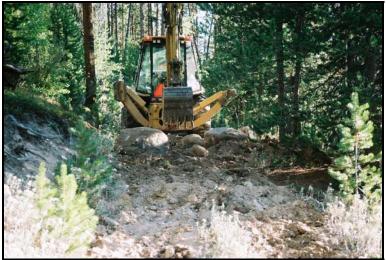
Figure 4.7.15. Decommissioning a non-system road at Sellar Lake, September 2007, (Photo Credit: Mark Lacy).

Above Ruedi Reservoir upland habitat is generally in good condition and supports sustainable populations of native wildlife. Headwater reaches are in designated wilderness and are managed for sustainability and wildlife values. Outside of the wilderness boundary the majority of upland habitat is publicly owned and managed by the USFS. Although these lands are also generally in good condition, dispersed recreational use is high for hiking, horse packing, fishing, camping, and hunting. The USFS maintains roads and trails, controls weeds, and has closed and reclaimed roads to reduce sediment delivery into adjacent streams (Figure 4.7.15). This work is ongoing throughout the sub-watershed.

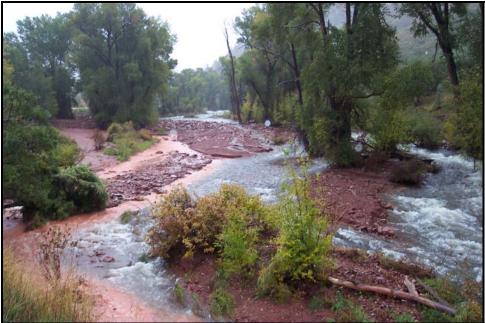
Figure 4.7.23. The Fryingpan River below the Seven Castles Creek debris flow that occurred on August 7, 2007 (Photo Credit: Chad Rudow, September 17, 2008).

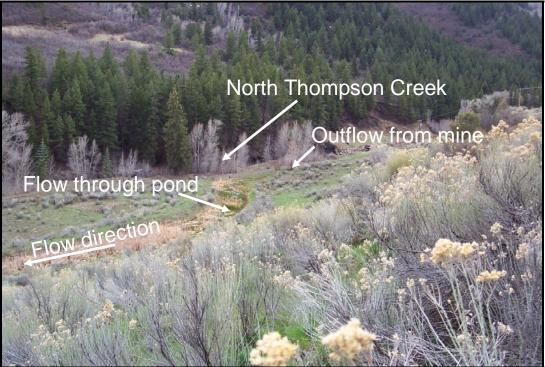
Figure 4.8.6. Part of the North Thompson Creek Mine outflow treatment system, April 17, 2007 (Photo credit: Chad Rudow).

Table 4.8.2 lists the permitted active and inactive mines in the sub-watershed. Both of the large coals mines are inactive. Reclamation activities occurred on the Coal Basin Mines from 1994-2000. CVEPA recently submitted a proposal to the USFS and the owner of a private in-holding to sponsor a reclamation project in this area. Reclamation is ongoing at the North Thompson Creek Mine (Figure 4.8.6). The Colorado Yule Marble Company began operation in 1905 and operated until 1941. It is most famous for producing the blocks of marble used for the Lincoln Memorial and Tomb of the Unknown Soldier. The quarry re-opened in 2004, and is operated by Polycor, a Canadian-based dimension stone company. Dimension stone is natural stone that has been cut to specific sizes and shapes.

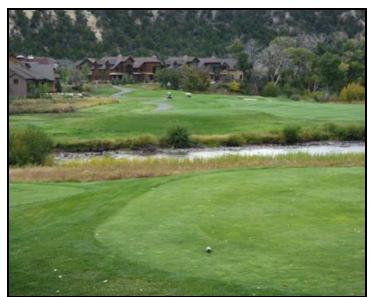
Figure 4.8.12. CR2-10: Replacement of riparian vegetation with a golf course has eliminated riparian functions such as pollution filtration, and has increased impermeable surfaces and runoff.

Both historic and recent land uses have altered the condition of riparian habitat, and, consequently, the river channel. Riparian habitat continues to be impacted by historic land uses such as railroad grades built on streambanks, mill sites and town sites built in the floodplain, and by domestic livestock grazing. Recent impacts have resulted from agricultural, highway, residential, and recreational activities (Figure 4.8.12). Over time, much of the upland and riparian areas that were historically degraded have been restored by natural processes, although channel degradation has not been completely remediated and stream function continues to be impaired. Additionally, new and ongoing development activities continue to encroach into riparian habitat, alter streambank vegetation, and degrade riparian habitat. The majority of the segment's riparian habitat has been modified and ecosystem functions degraded. On the left bank, riparian habitat is high quality on 3 percent of the segment, slightly modified on 8 percent, moderately modified on 17 percent, heavily modified on 44 percent, and severely degraded on 28 percent. On the right bank, 3 percent of riparian habitat is high quality, 10 percent slightly modified, 13 percent moderately modified, 55 percent heavily modified, and 19 percent severely degraded. The extent and type of activities that have modified riparian and instream habitat in the Crystal River segment are summarized in Table 4.8.5.

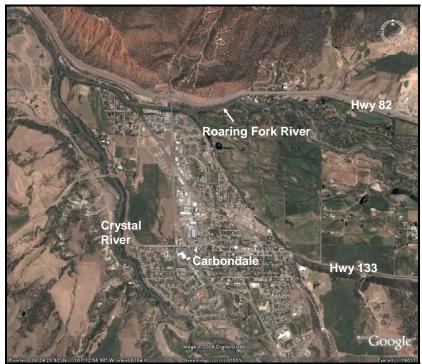
Figure 4.8.17. Confluence of the Crystal and Roaring Fork rivers (Source: Google Earth image, downloaded March 23, 2008).

The Crystal River runs predominately south to north before joining the Roaring Fork River (Figure 4.8.17). Carbondale is situated at the confluence of these two rivers. From the confluence upstream to Thompson Creek the river is in a broad alluvial valley that remains in agricultural use. Parts of the historic river channel were braided and complex, and interacted with the floodplain annually. This interaction created new channels with large cottonwood galleries, large pools, water-dependent shrub and grass species, and extensive wetland complexes from beaver dam construction. This reach was simplified by urbanization and agriculture, leaving the river as a single, wide, shallow, and incised channel that rarely flowed over its banks. Additionally, large wood and beaver dams were removed to improve agricultural lands and create more suitable building sites, thus further simplifying the channel.

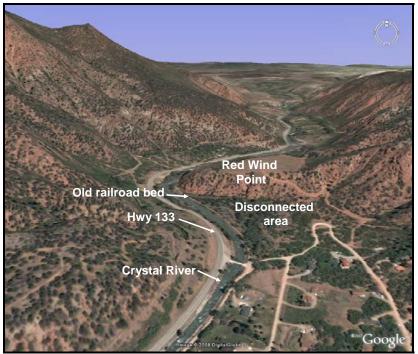
Figure 4.8.18. Upstream of Red Wind Point, the meander channel was cut off by the old railroad line (Source: Google Earth image, downloaded March 24, 2008).

Upstream of Thompson Creek the river enters a canyon reach upstream to Placita. The natural orientation and topography reduce solar input, resulting in decreased primary plant production. The instream habitat is altered from historic railroad construction and, currently, from Highway 133. Many of the streambanks along the railroad grade have restored naturally and are well-vegetated with stable banks. Although naturally constrained by the canyon, the channel is further constrained from these transportation features, which disconnect many areas where the channel historically meandered. Several of these locations are easily observed today, including just upstream of Red Wind Point, where the old railroad grade cut off the adjacent floodplain to the east (Figure 4.8.18). Two large tributaries (Avalanche and Coal creeks) flow into the Crystal

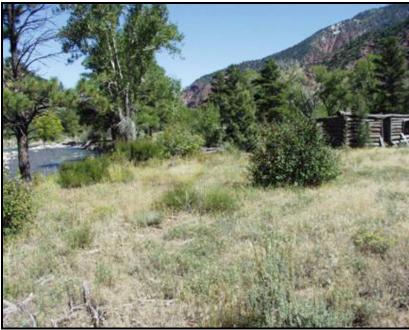
Figure 4.8.20. CR2-7: A combination of historic and recent development impacts have resulted in drier soils that have changed riparian vegetation to upland vegetation.

River, depositing alluvial fans that form wider valleys within this canyon reach (including the Janeway and Redstone townsite areas) (Figure 4.8.19) and creating "hot spots" for aquatic life. These important aquatic zones are discussed further in Section 3.4. At the historic townsite of Janeway in reach CR2-7, the channel's current condition is caused by the cumulative impacts of historic townsite development and recent highway development, which have channelized and straightened the stream and contributed to bank erosion that inhibits overbanking flows. The resultant drier soils foster the invasion of upland plant species such as oak, juniper, and sage into riparian habitat. These drought-tolerant upland species do not stabilize bank soils effectively, leading to erosion and channel alteration (Figure 4.8.20). Conversely, the Placita meadow is a classic hot spot of animal diversity, where stable braided channels, beaver dams, and sediment and wood deposition create complex habitat for both aquatic and terrestrial wildlife (Figure 4.8.21).

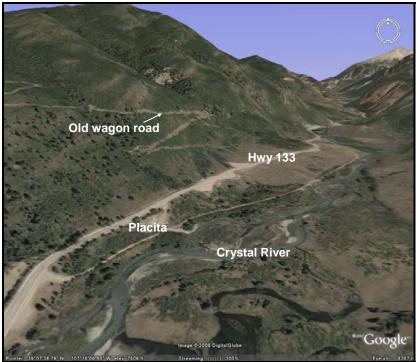
Figure 4.8.21. Historic townsite of Placita (Source: Google Earth image, downloaded March 23, 2008).
