CATALOG OF STREAM AND RIPARIAN HABITAT QUALITY FOR THE ROARING FORK RIVER AND TRIBUTARIES, CENTRAL COLORADO

Prepared by the Roaring Fork Stream Health Initiative

Delia G. Malone, M.S.E.S.
and
John C. Emerick, Ph.D.

March 7, 2007

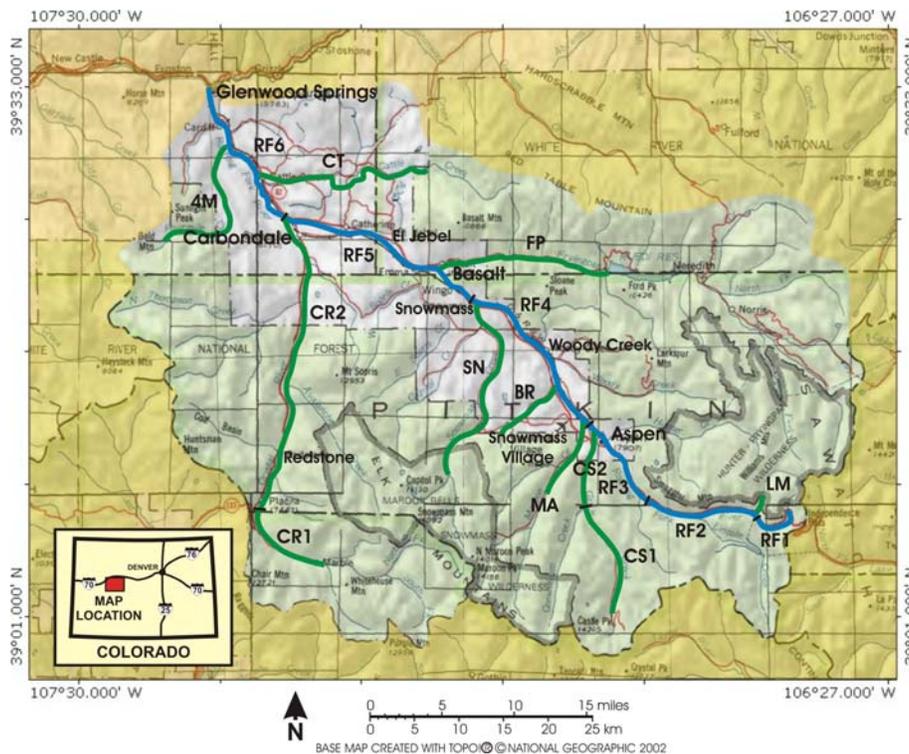
The Roaring Fork Watershed, showing the 17 stream segments assessed by the Stream Health Initiative. The Roaring Fork River segments (6) are shown in blue; tributaries are in green.

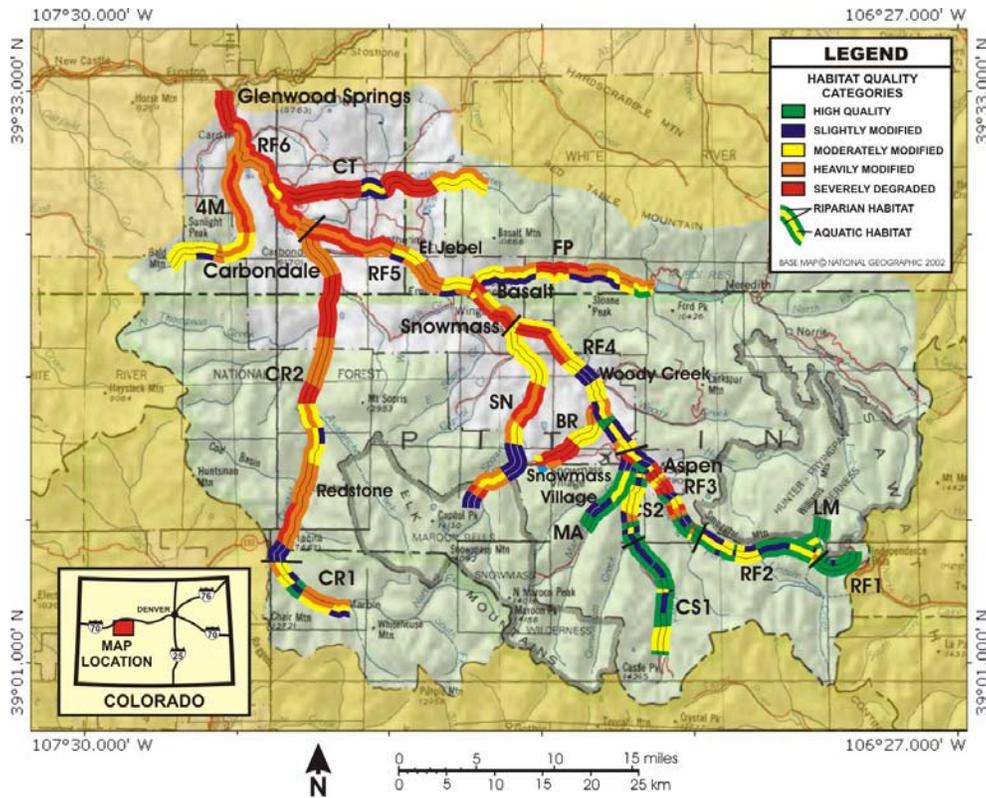
A generalized habitat quality map of the Roaring Fork Watershed, showing the reaches assessed in this project. Each reach is depicted as a band of three stripes, with the outer stripes representing the habitat quality of the right and left banks (looking downstream), and the center stripe representing the in-stream habitat quality.

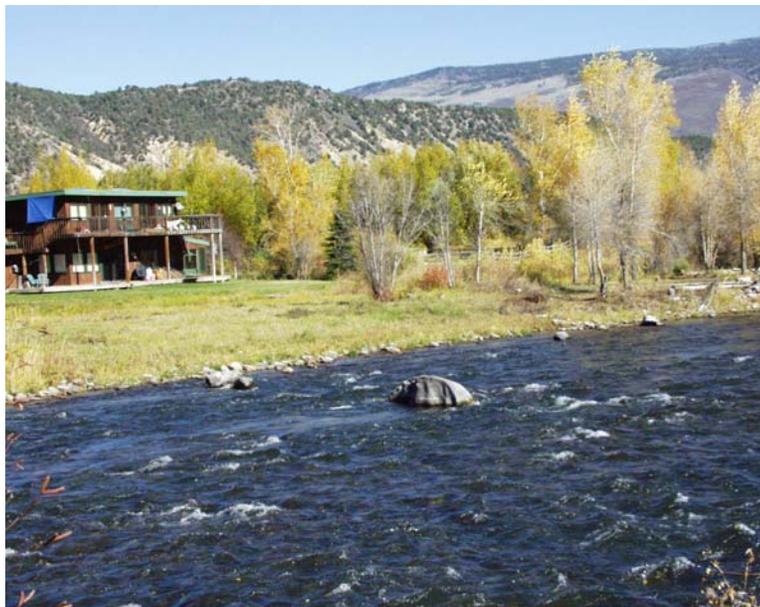
Rural housing development has frequently included removal of riparian vegetation, which has resulted in bank erosion and stream degradation.

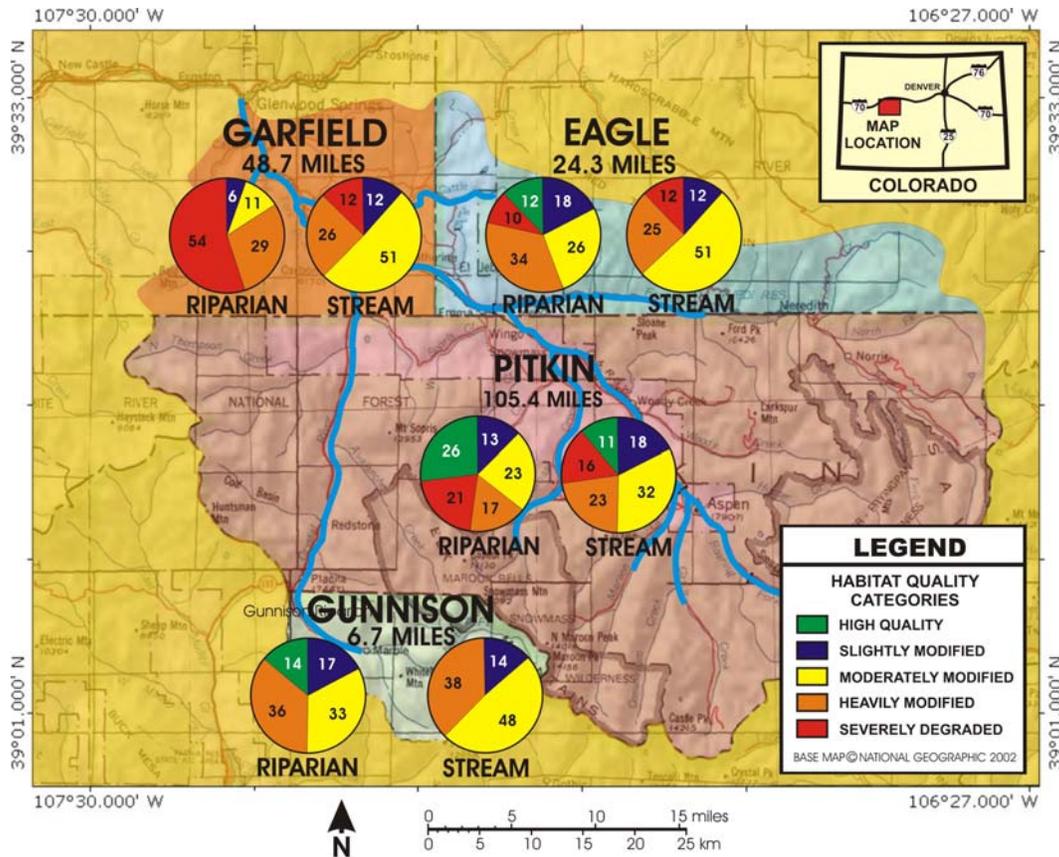
The map below shows the distribution of stream and riparian habitat quality in each of the four counties in the watershed, based on the stream miles assessed by the project. Results shown here are influenced by where the county is located in the watershed, and how many headwater stream miles were assessed in each county.

The distribution of stream and riparian habitat quality in each of the four counties in the watershed

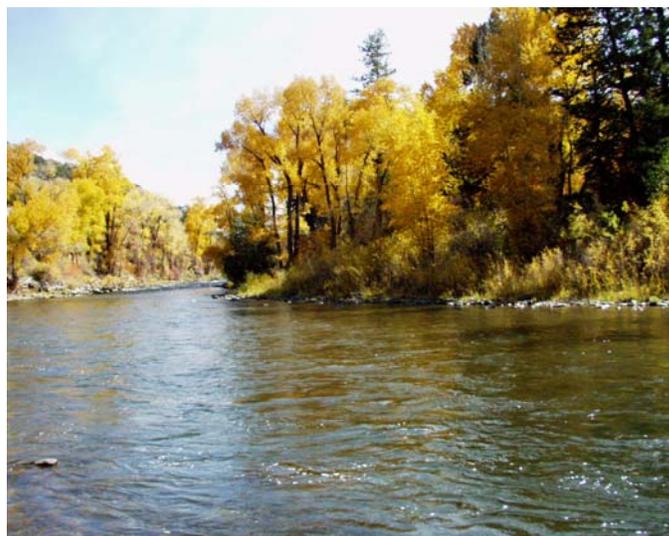
In spite of intense land development pressure, there are still areas where healthy riparian habitat survives, such as here near El Jebel. In places like this, stable stream banks have a beneficial effect on fish habitat, and the riparian vegetation provides diverse habitat for birds and other wildlife.

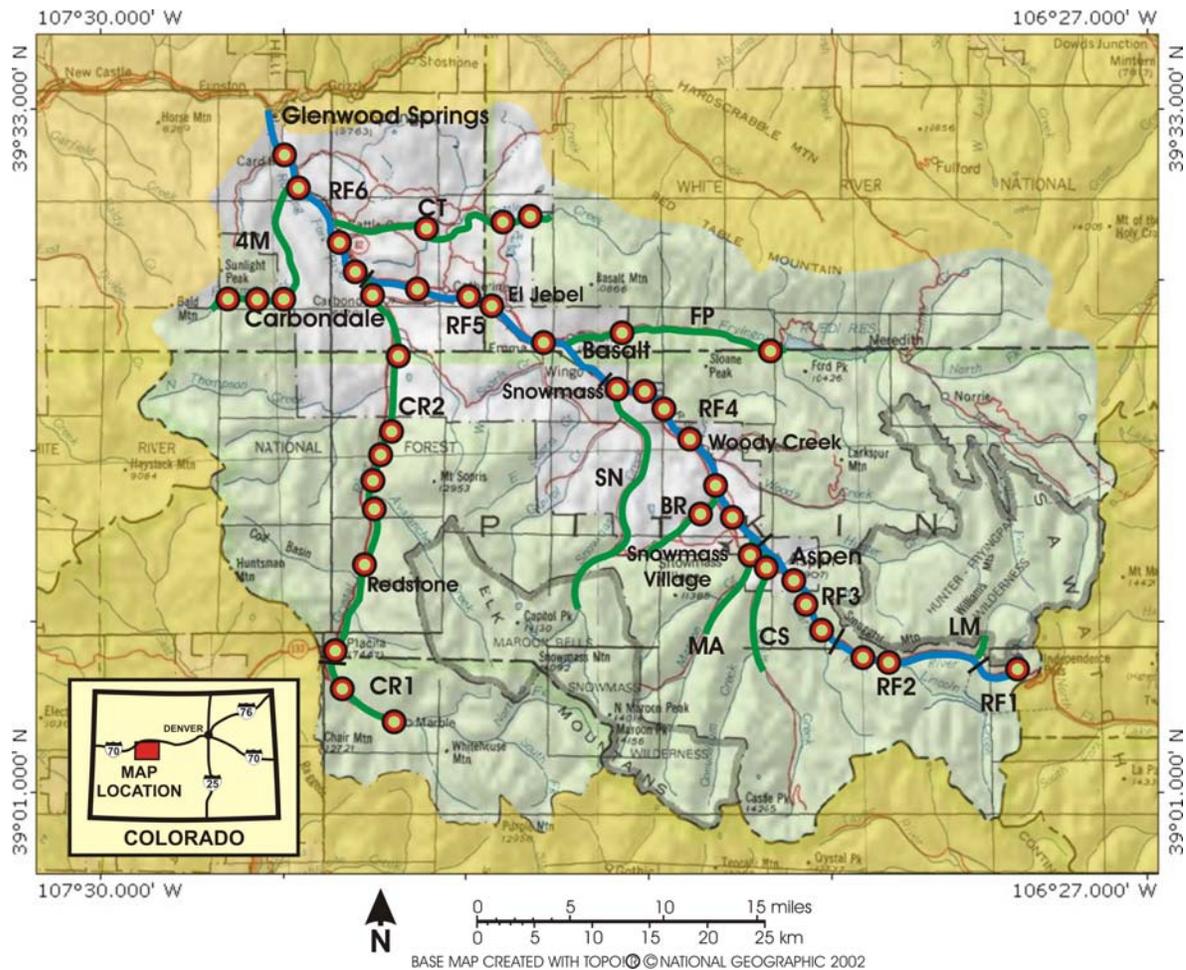
The map above shows the location of 40 Conservation Areas of Concern identified by the project.

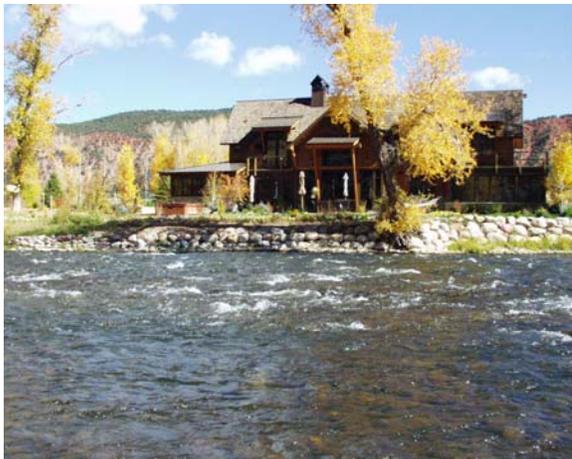
Vegetation removal in this golf community has destabilized stream banks, reduced shade that maintains cooler water temperatures and eliminated both aquatic and riparian wildlife habitat. Boulder rip-rap on the banks channelizes stream energy toward the next unprotected area downstream.

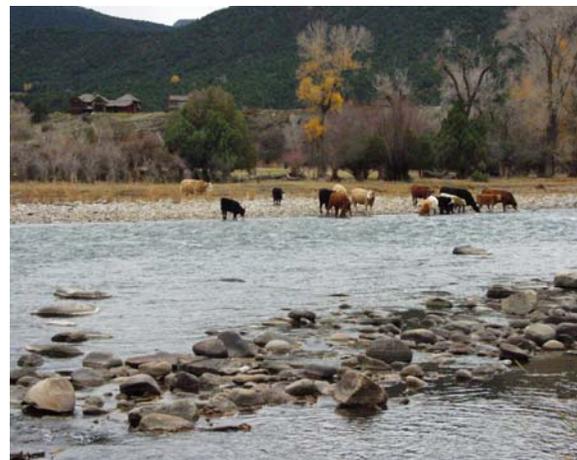
Cattle degrade water quality and destroy riparian habitat. Some of the ranches in the valley fence their livestock out of the riparian zone and allow access to water only at specific places, which results in a much healthier river system.

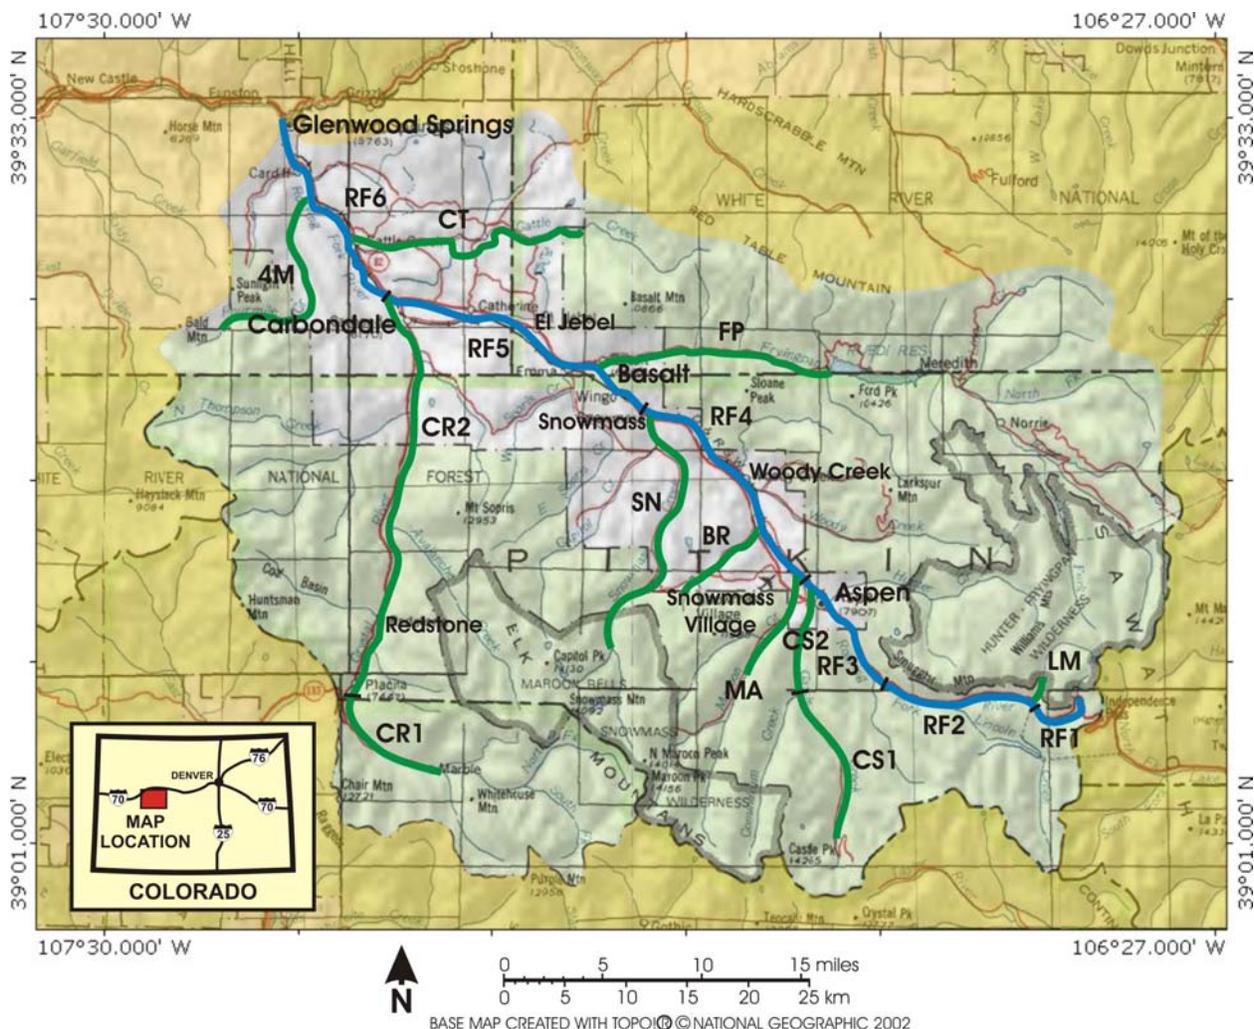
Figure 1. Map of the Roaring Fork Watershed showing stream segments documented in this catalog.
