CRYSTAL RIVER, SEGMENT 2

Base of McClure Pass to the Roaring Fork River

6.13.1 Crystal River, Segment 2

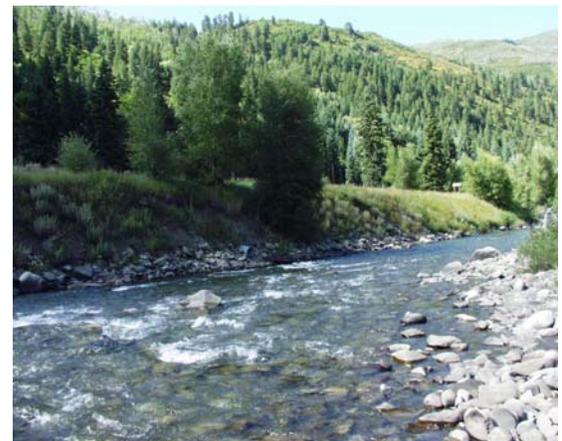
Middle: Highway 133 channelizes the stream and fragments wildlife habitat.

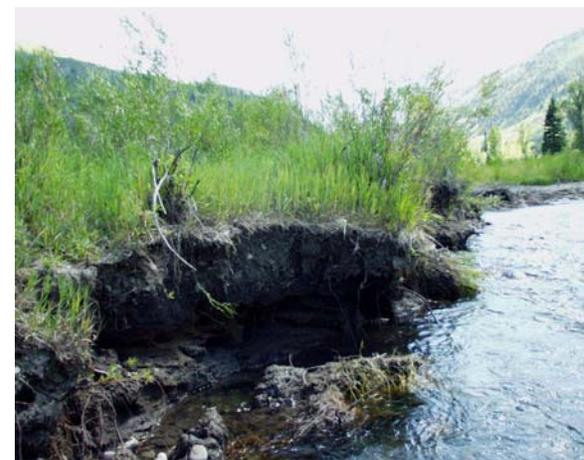
Above: Mid-channel islands provide elk with protected habitat for calves and create side channels where fish find protective cover. Below: Where native plants have been removed and replaced with pasture grasses bank failure occurs.

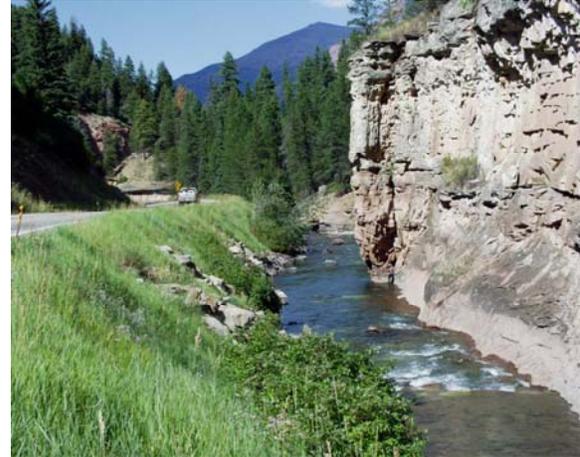
Left: Bedrock controls the right bank but the highway confines the left bank and inhibits meandering.

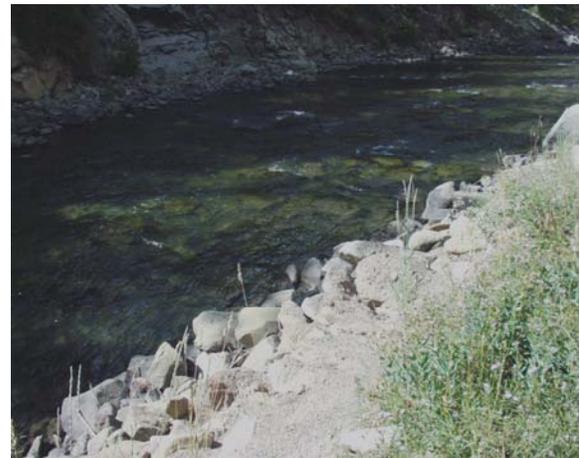
Right: Road-base gravel has been flushed into the stream by runoff, filling pools and embedding cobbles.

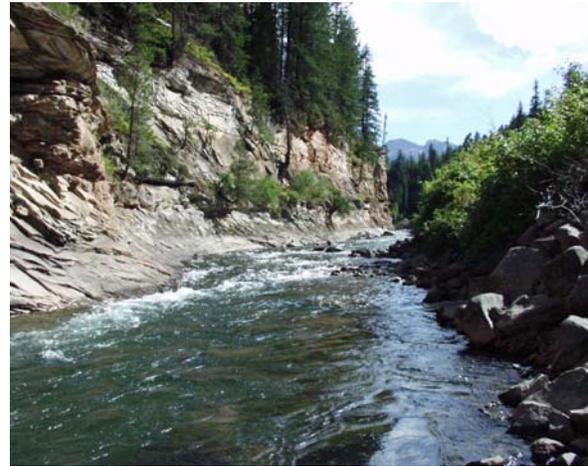
By confining the channel, the highway has inhibited the development of pointbars where riparian habitat could flourish. Trees that gain a toehold in the bedrock crevices provide good nest sites for songbirds.

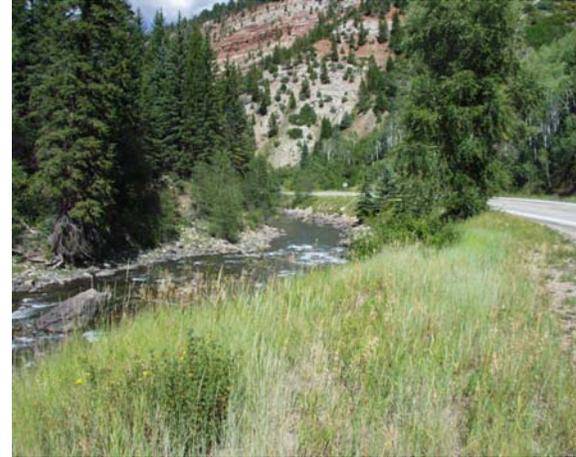
Noxious weeds find a path for invasion along road cuts.

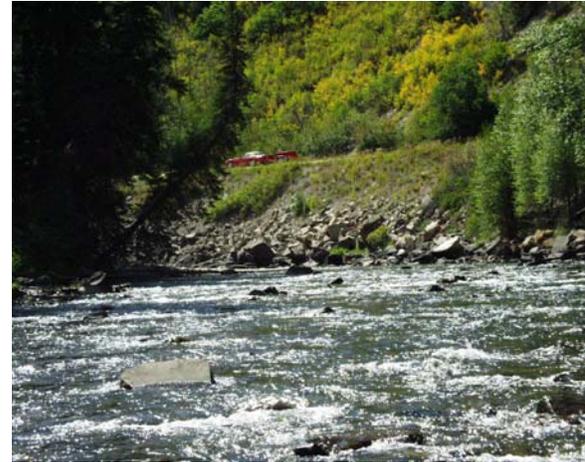
Without riparian vegetation to act as a filter, road-based pollutants are carried directly into the stream with precipitation runoff.

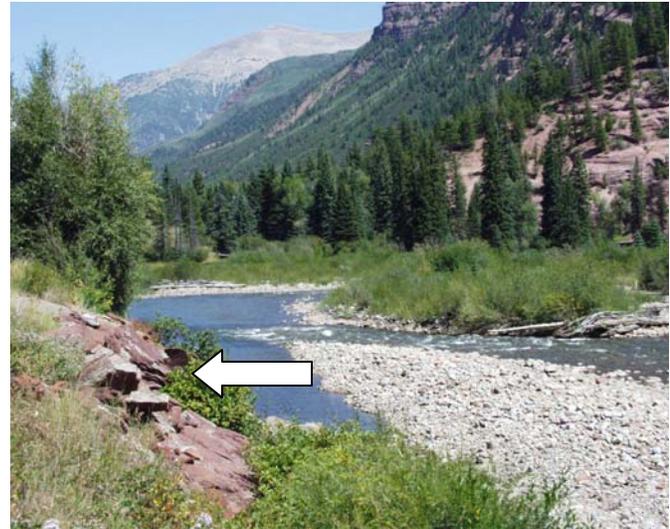
Above: At the top of the reach Highway 133 is typically >50 m away from the stream and only channelizes small parts of the reach – riprapped road cut is at the left of the photo.

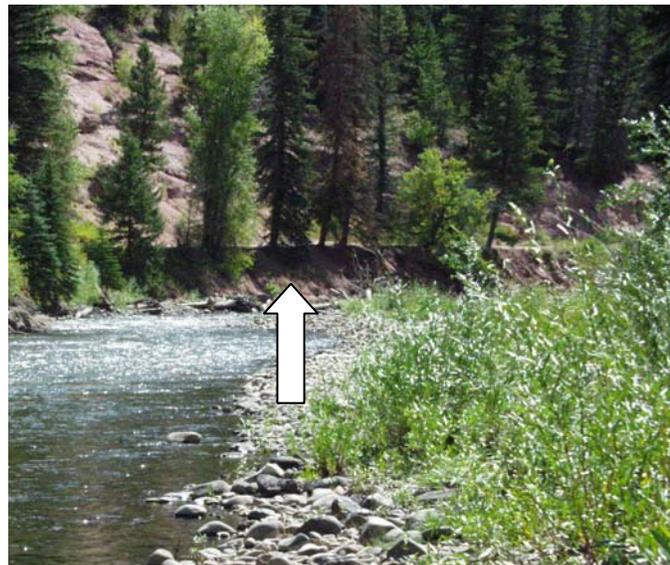
Below: Just upstream from the Town of Redstone, an unpaved road contributes to channelization and stream sedimentation.

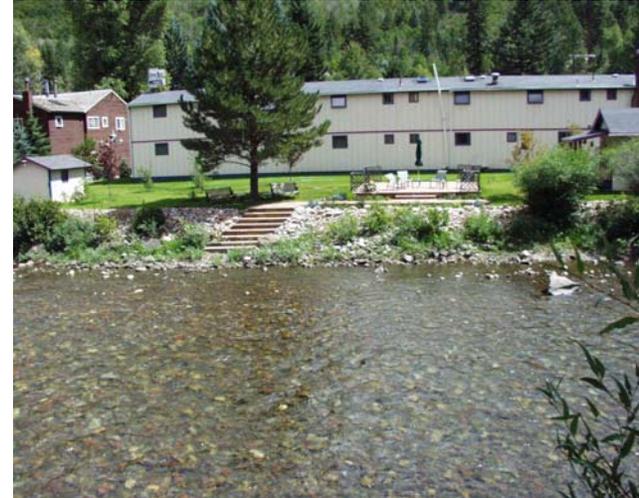
Above: Removal of riparian vegetation along the majority of stream banks in the Town of Redstone has contributed to bank instability and erosion.

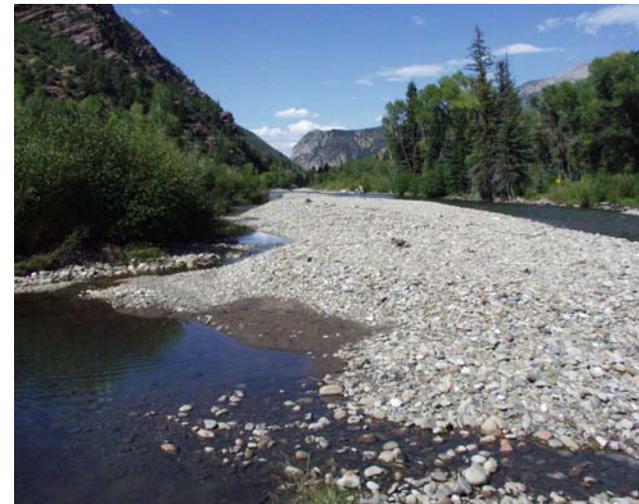
Below: Large, unvegetated deposits of cobble, sand, and silt signal stream imbalance.

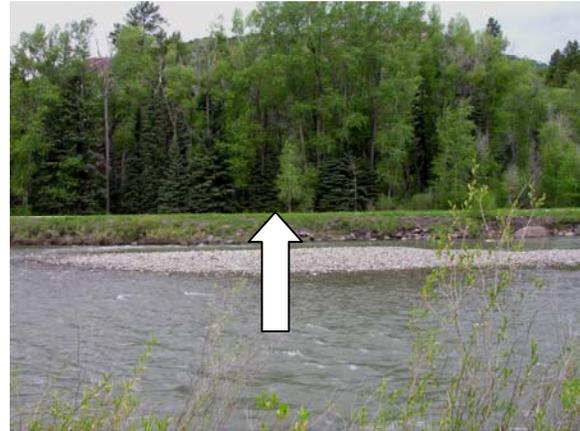
The Highway 133 road grade fragments the stream ecosystem by disrupting the connection between the stream and the riparian habitat that is on the other side of the road. The highway is a lethal barrier to wildlife and contributes road-based pollutants to the stream.

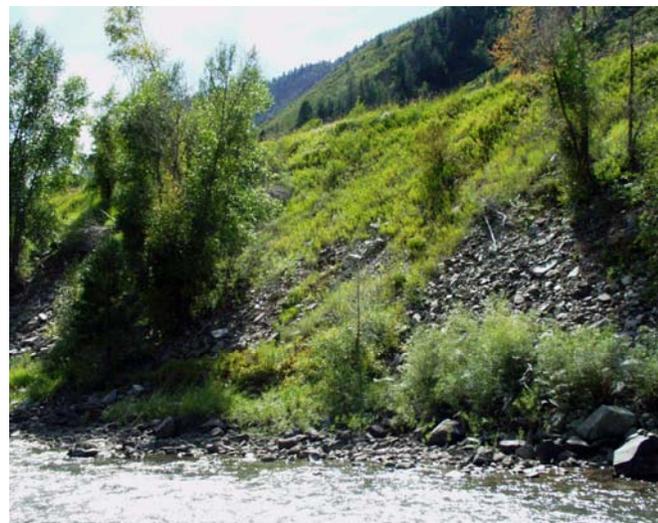
Below: On the lower part of the reach road cut impacts have degraded the riparian and stream habitat. Riparian vegetation is degraded, banks are eroding and stream habitat is simplified.

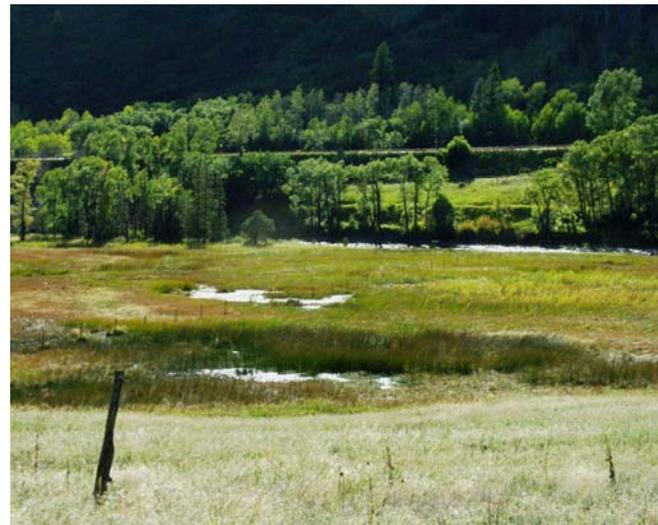
High quality vegetation at Filoha Meadows provides important elk calving and bighorn lambing habitat. In the fall, elk bugling is commonplace, and in the winter, the area serves as critical winter range for bighorn.

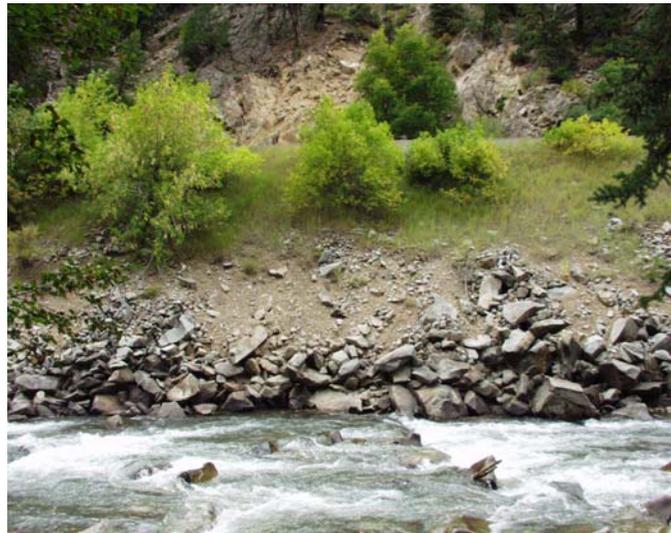
Below: On the right bank, natural recovery is occurring.

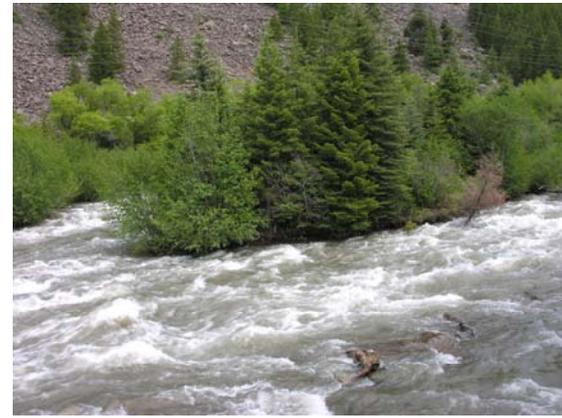
Above: Mid-channel islands slow flood energy and providing wildlife habitat.

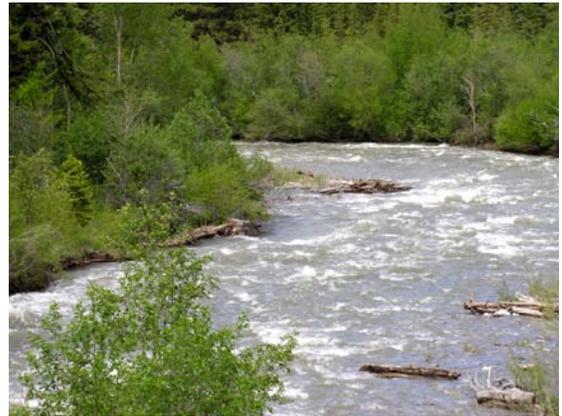
Middle: A sinuous channel shape has redeveloped towards the middle of the reach, increasing stream diversity and function.

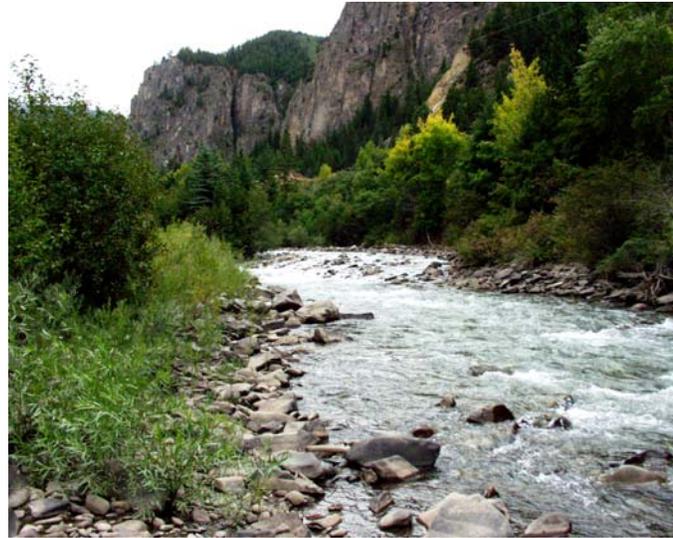
Above: Near the confluence of Avalanche Creek riparian habitat has recovered and is in good condition providing good wildlife potential for large mammals such as elk and also for smaller critters such as songbirds.

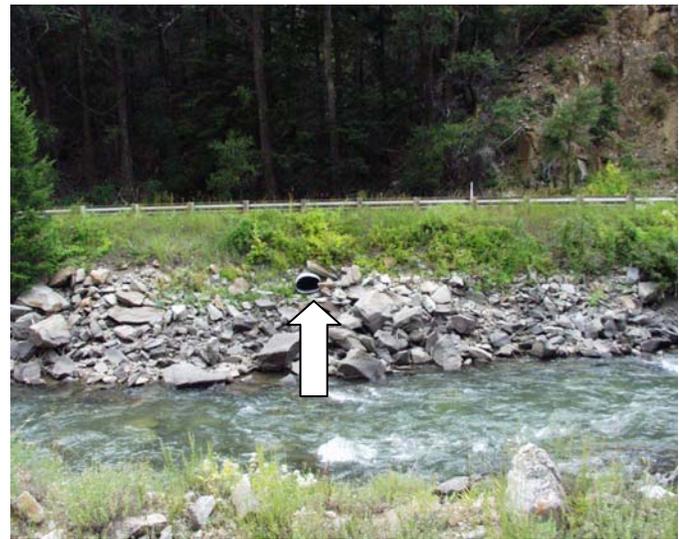
Below: The highway road cut degrades bank vegetation and the road is a source of stream pollution via indirect runoff and also directly via culverts that direct polluted runoff into the stream.

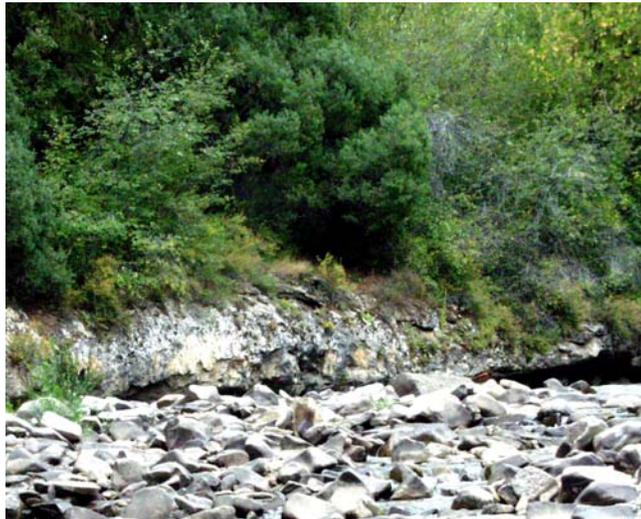
Warm ground water discharge fills this pond on the right bank. Two common yellowthroats, a male and a female, were observed foraging at this pond.

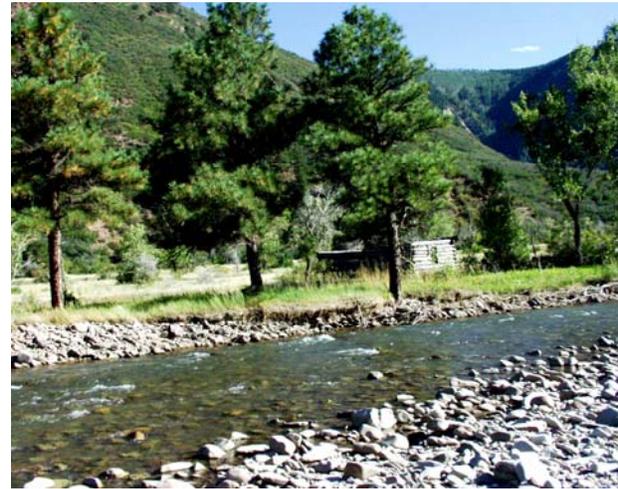
Above: Channelization and consequent hydrologic alteration has severely altered both instream and riparian habitat.

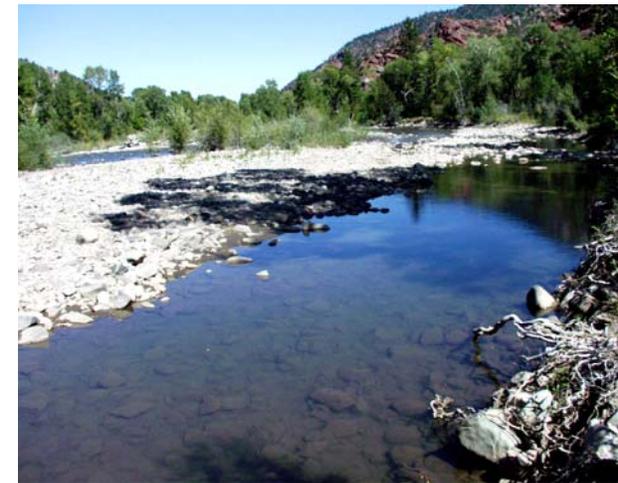
Below: Excessive bedload in combination with channel widening has resulted in large unstable cobble deposits.

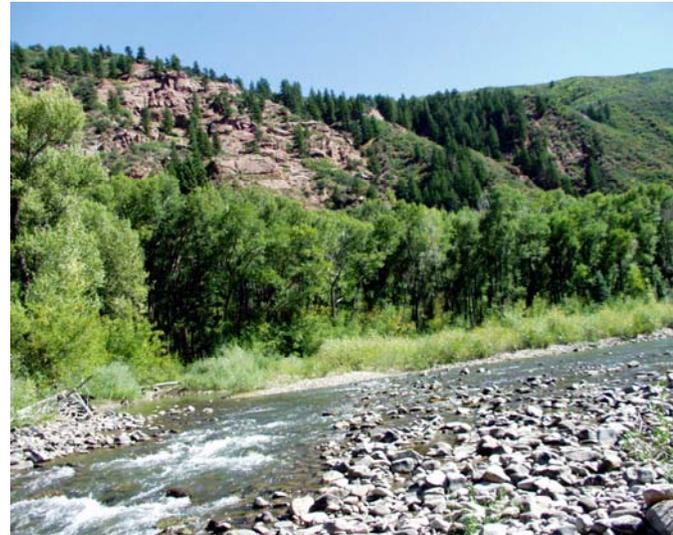
Cottonwood forest thrive on the lower part of the reach on the right bank where overbanking flows recharge soil moisture.

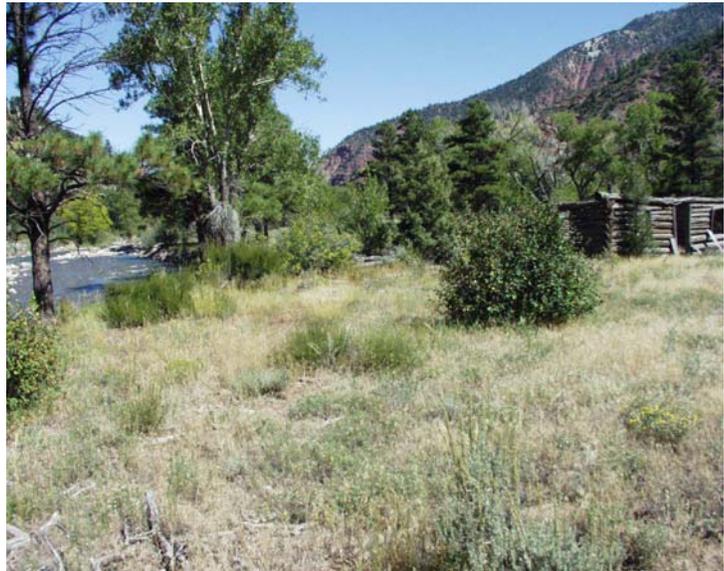
At the Janeway townsite, lack of overbanking flows has resulted in drying soils with a consequent change in the plant community to one that is characterized by drought-tolerant species such as bitterbrush, mountain mahogany and sage.

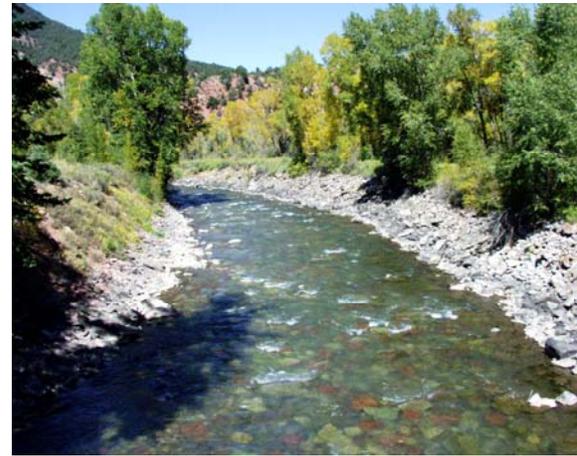
Above: The highway grade on the left and railroad grade on the right bank channelize and simplify >50% of the reach.

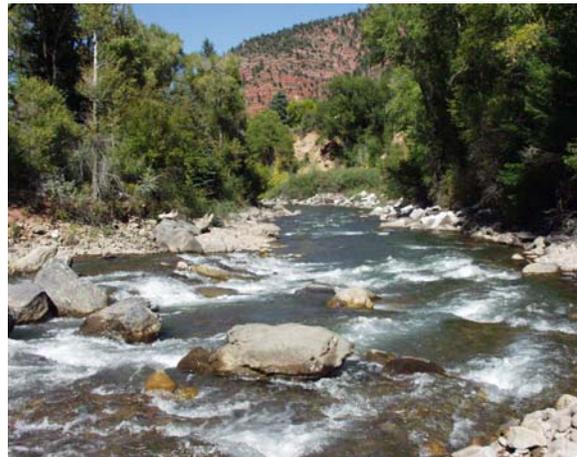
Below: Unchannelized sections of the stream have a good variety of velocity/depth regimes that create runs, riffles and pools.

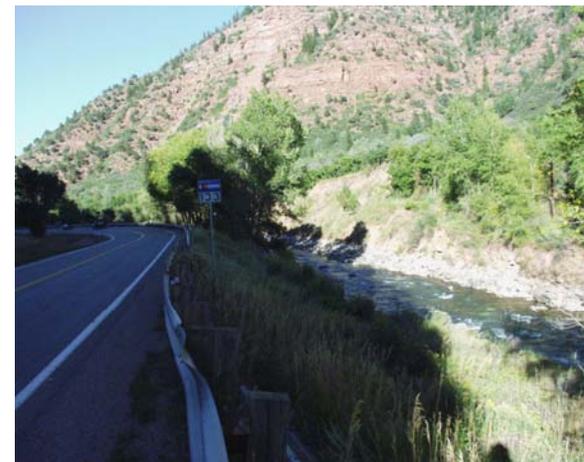
Above: Small pockets of good quality riparian habitat provide some wildlife potential.
Below: Highway 133 degrades stream and riparian habitat and is a lethal barrier to wildlife attempting to access the stream.

- Minimize human disturbance
- Highway 133 isolates upland from stream ecosystems and is a lethal barrier for wildlife;
 - Provide wildlife appropriate underpasses and or overpasses.

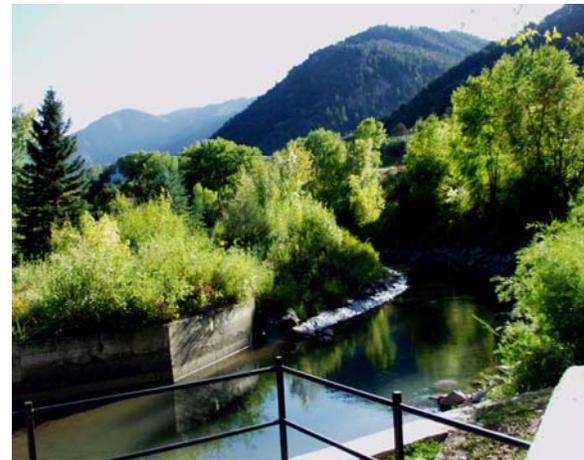
A large diversion (bank-full width = 9m) contributes to dewatering and channelization.

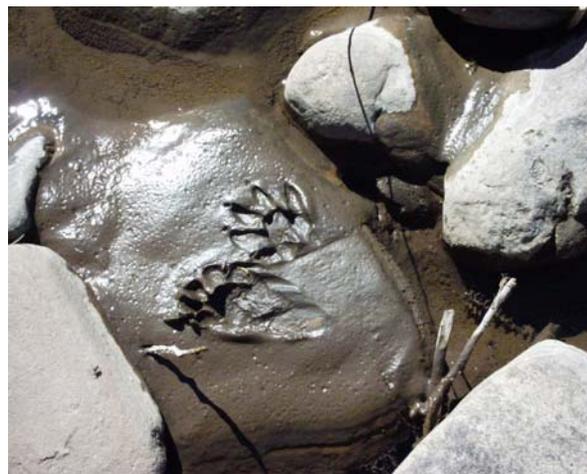
Right: Disturbed habitats that are common in this stream corridor select for wildlife species that are tolerant of disturbance and of human activity. Raccoon tracks were the most frequently observed mammal sign along this reach.

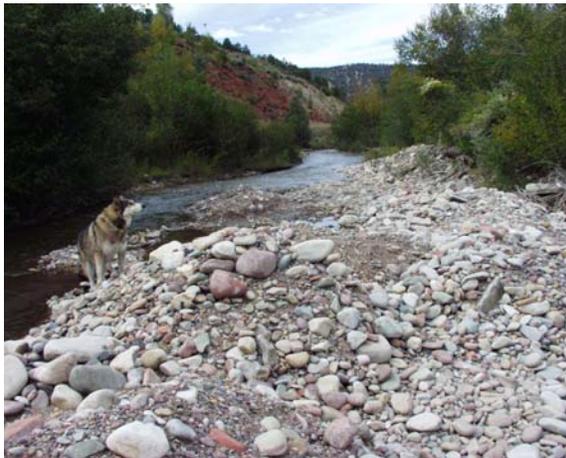
Left: The channel has been dredged to create a large irrigation diversion on the left. In the process, stream substrate has been disturbed and aquatic wildlife habitat destroyed.

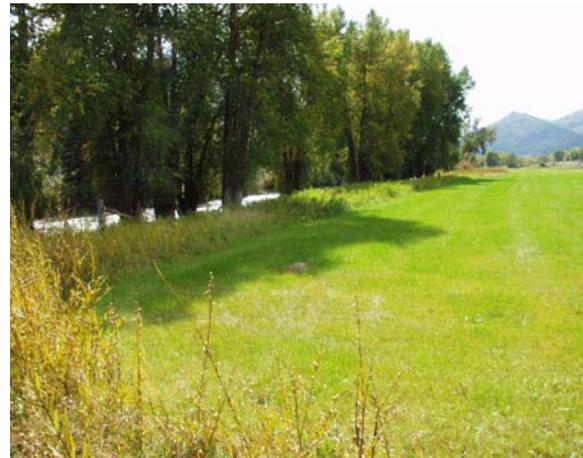
Right: Riparian floodplain conversion to pasture has left only a narrow border of riparian vegetation. Little cottonwood recruitment occurs along this reach so these mature trees are not being replaced when they die.

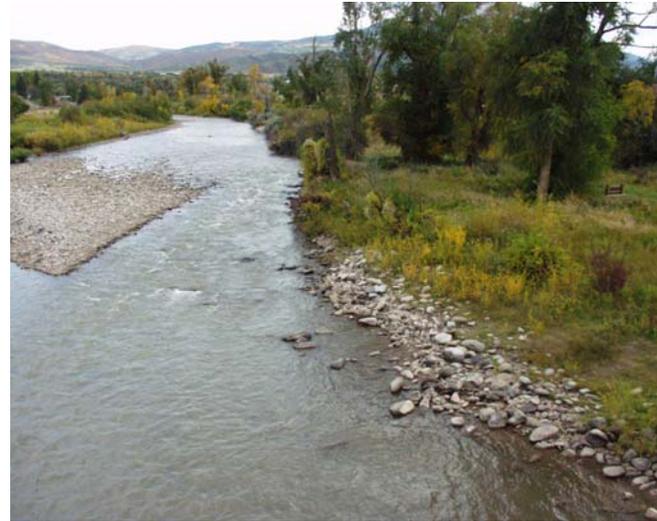
Above: Stream habitat has been simplified by channelizing impacts that have resulted in channel straightening and widening and stream shallowing.

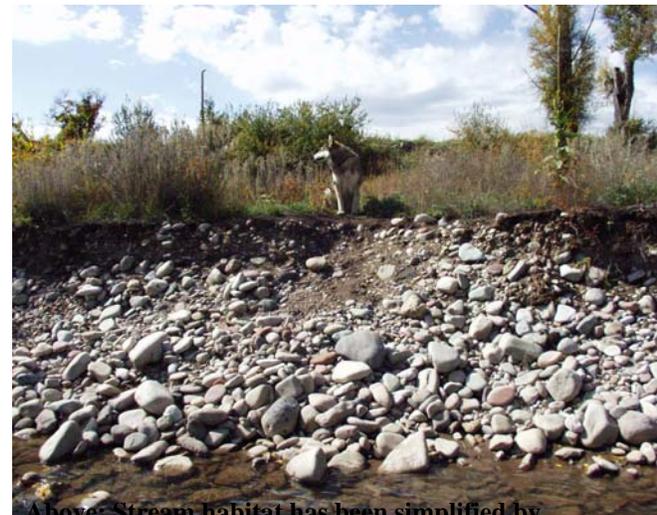
Below: Weeds that dominate habitat at the top of the bank do not have the capacity to stabilize soils, and erosion results.

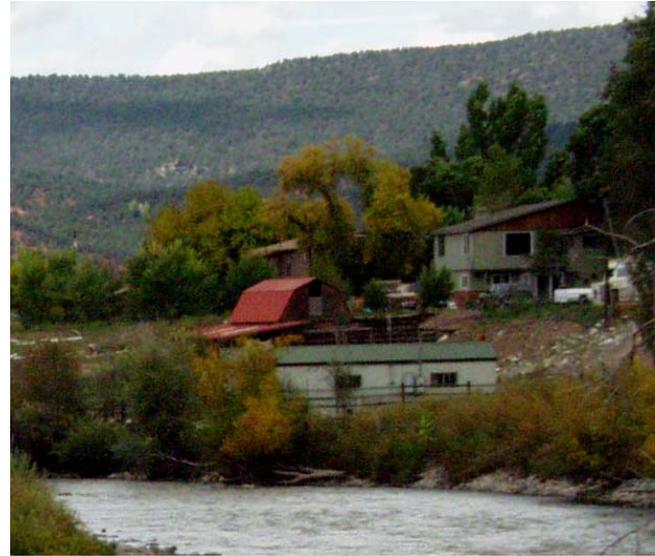
Riparian zone vegetated width has been decreased and is insufficient to adequately prevent nutrients from horse and llama corrals from moving into and polluting the stream with excessive nutrients.

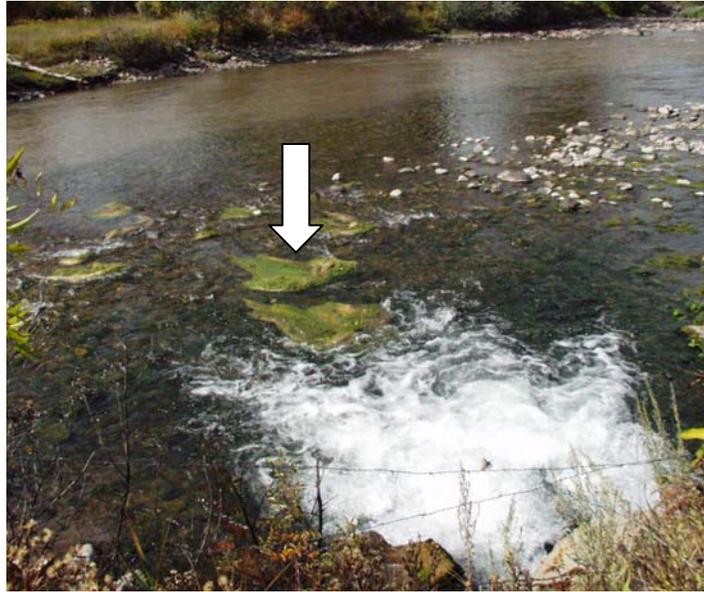
Algal blooms occur where nutrient-rich effluent from fish hatchery ponds discharges into the stream.
